# ALL SAINTS, THORNTON HOUGH

Quinquennial Inspection

Chambers Conservation Ltd, May 2026 – Issue 2

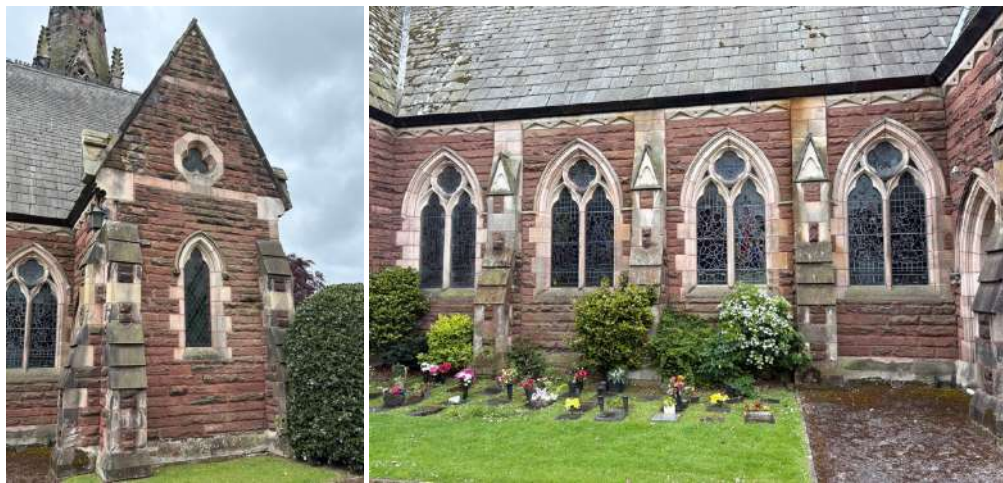
- 3.1.4 Work / needed with / issues noted with regards to specific areas:
- North porch: Minor open joints to the plinth and the monoderm red mortar is cracking slightly. Open joints to the top of the apex stone of the parapet coping. Generally, condition appears slightly improved, as masonry previous described as being saturated. Whilst some staining remains, there is little evidence of long-term wetness.

- North nave: Pointing generally intact, except a few open joints nearer the base. Some staining but seems drier than previous report.
  - North transept (similar to previous report): open mortar joints to the plinth and algae staining around the downpipe. Again, dry at the time of the inspection, so damage / staining probably historic. The apex stone to the coping is leaning inwards slightly with an open joint beneath – this may have been caused by expanding ironwork. The mortar joint under the coping is generally recessed. Patch pointing at high level would be beneficial when high level access available.

*North porch and north nave elevations*

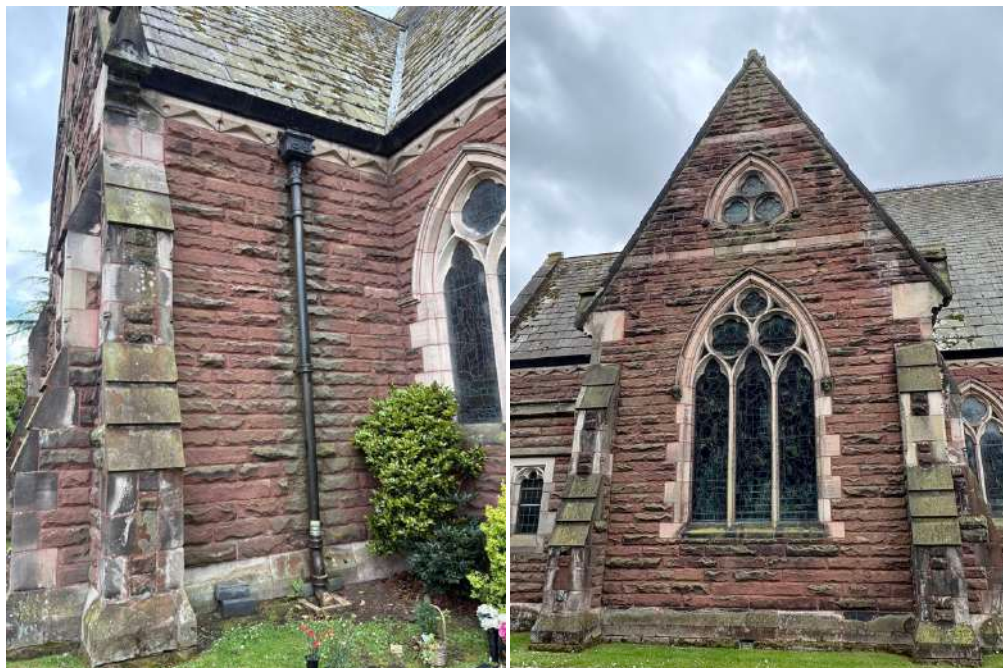
*North transept*

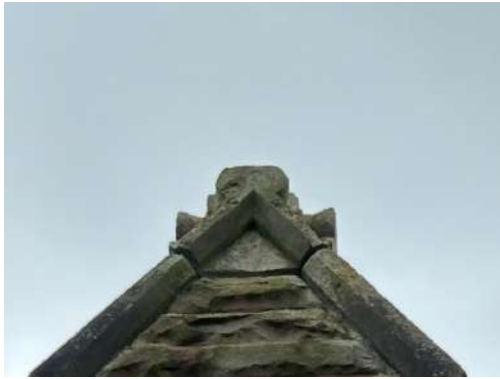
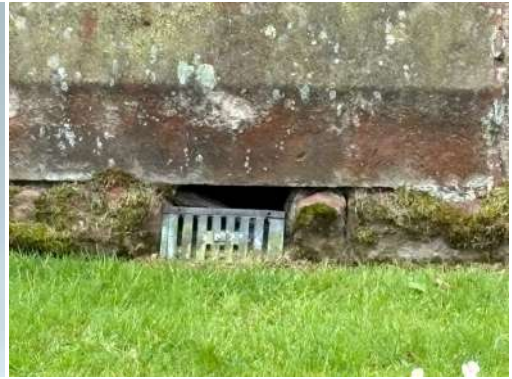
*North transept - issues at apex stone and loose vent*

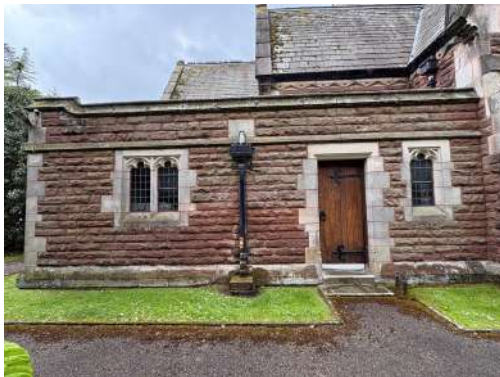
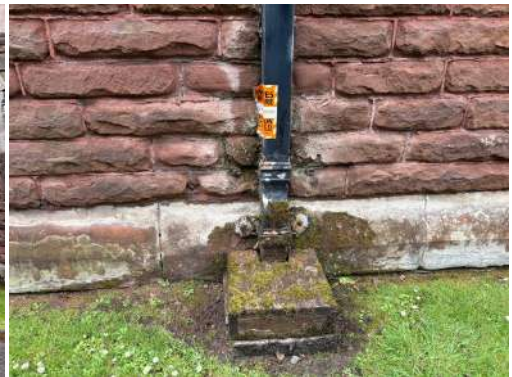
- Choir vestry: the mortar, together with dampness from the downpipe and roof is causing the saturation of the stonework and its gradual degradation. This will be worsened by it being shaded and north-facing. Visually, the pointing is failing dramatically in appearance, although this is largely the superficial later mortar falling away. This area should be a priority for repointing after rainwater goods issues are fixed (included elsewhere).

*Choir vestry*

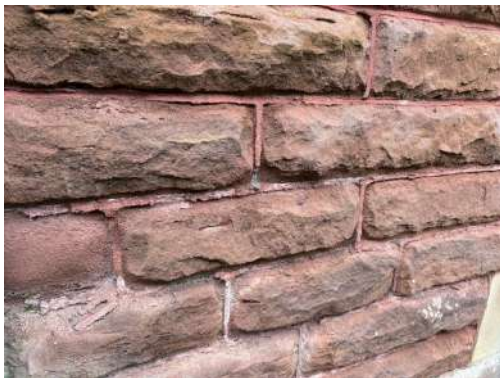
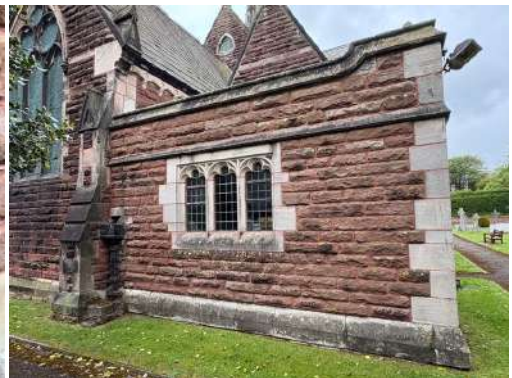
*Choir vestry failing pointing and east side*

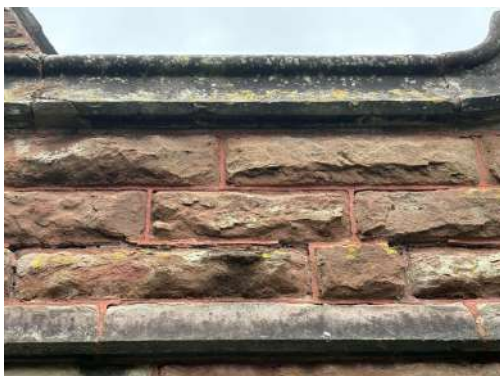
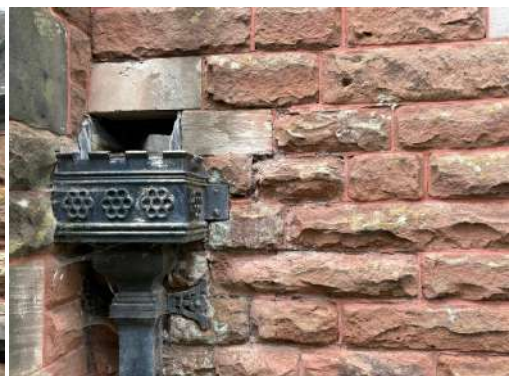
*Choir vestry failing pointing on east side and deterioration around outlet*

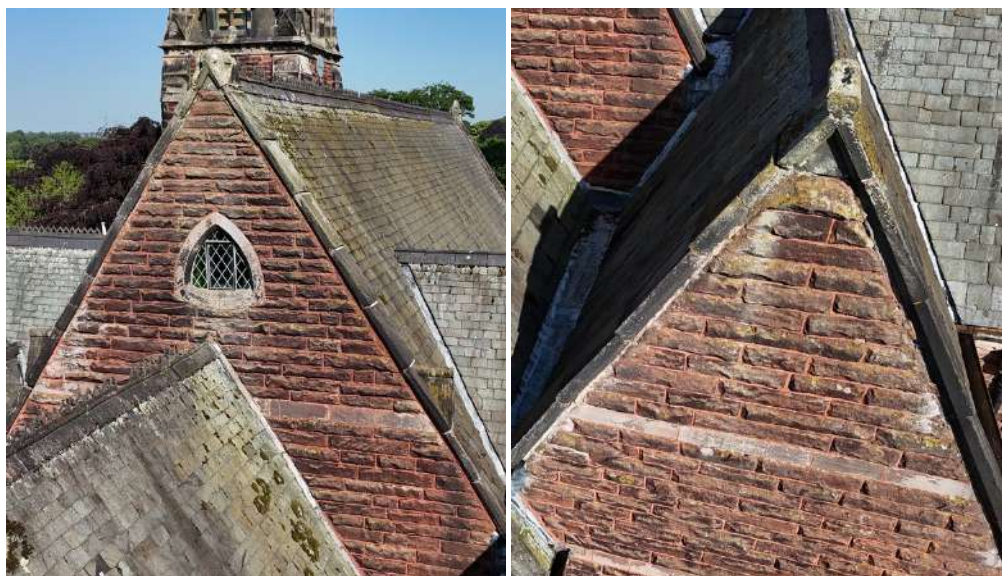
- Organ chamber transept (similar to previous report): Appears generally sound where visible from ground level / drone (it is largely obscured at ground level by the choir vestry) – the main exception is the open joints around the apex stone, again. When high level access available, its condition should be checked further.

- Chancel, east elevation: The coping stones remain quite irregular, with mortar missing from both the underside and face. The apex stone also remains higher, implying there might be rusting metalwork securing it, although this has not worsened. The pointing is cracked but intact, except to the base and occasionally at higher level, e.g. around the kneelers.

*East nave and organ chamber transept gables viewed from a drone*

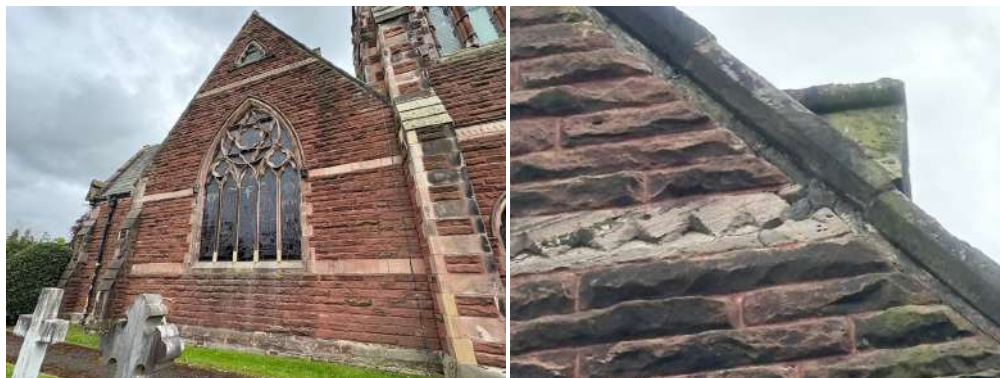
- Nave west elevation: The copings appear to be in fair condition. Some damage was noted to the stone string detail at the edges.
- Nave east elevation (high level): Viewed only from drone. Salting and algae growth to left hand side in line with chancel ridge, possibly indicting water getting in under parapet coping. This area should be monitored, particularly for internal leaks.

*West nave elevation*

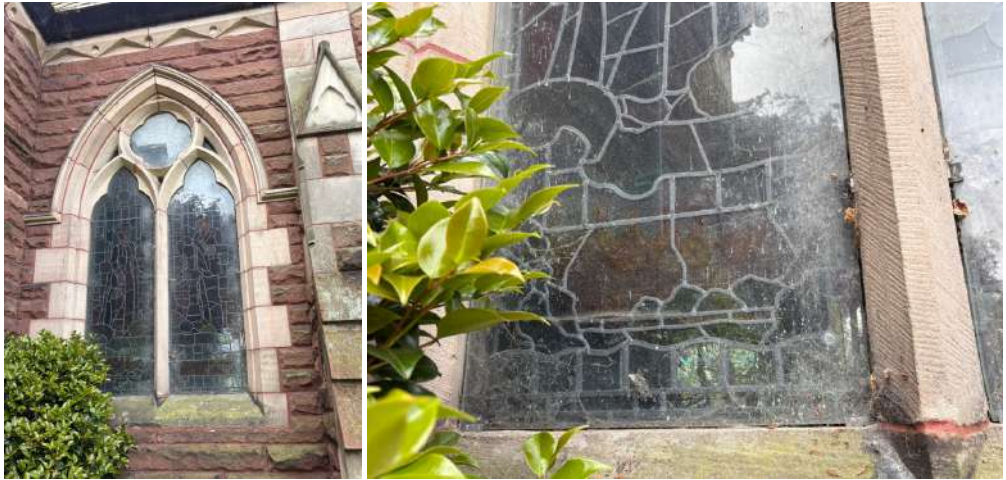
- North nave – attractive stained-glass windows protected externally with polycarbonate. Whilst it is good that the tracery remains unobscured, the polycarbonate is not yellowing and seems to be partially ventilated, there is an increasing amount of debris gathering between the two surfaces. It is strongly suggested that the polycarbonate is temporarily removed and the window carefully cleaned (and checked) before refixing.

*North nave windows and dirt / debris behind polycarbonate*

3.3.4 Generally, the windows would benefit for checking closely every five years, removing and refixing any guarding after gently cleaning the windows. External metalwork (such as opening hoppers) should be redecorated.

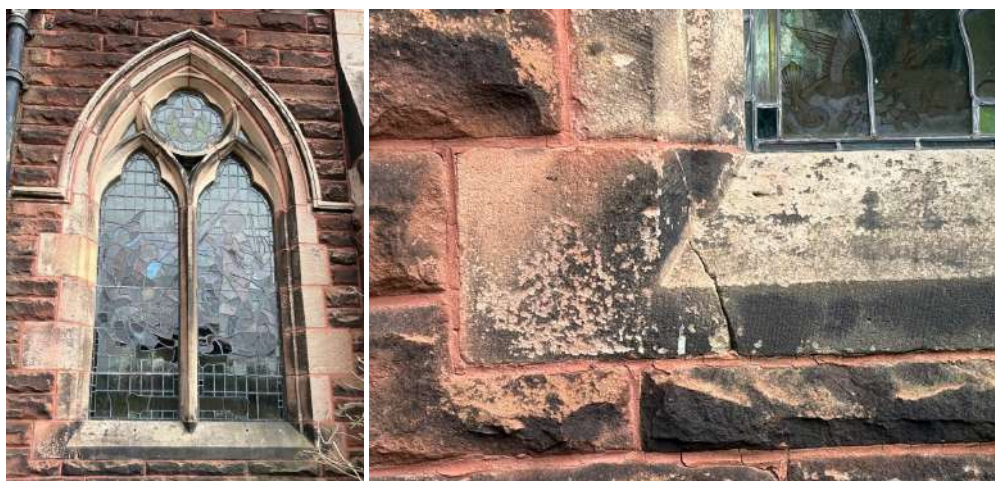
- Nave south, centre window – later mullion
- Nave south, left-hand window -cracked cill, although this has not worsened.
- Nave west – later replacement to bases of mullions.

*Nave south elevation window – cracked cill*

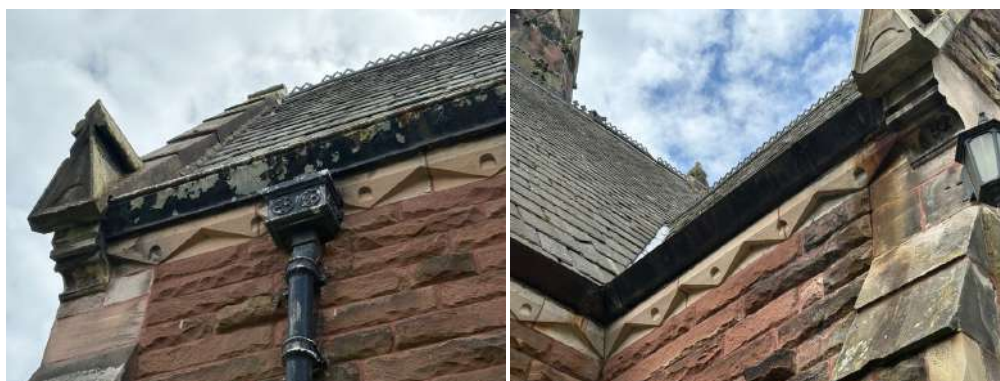
- North porch, west side – gutter and downpipe corroding. Downpipe presumed to be a later replacement to an earlier square section. Twigs in hopper requiring removal.

- North porch, west side – gutter a later replacement without decoration. In previous inspection reported to be failing badly at both ends and saturating masonry but somewhat better now.

*North porch rainwater goods*

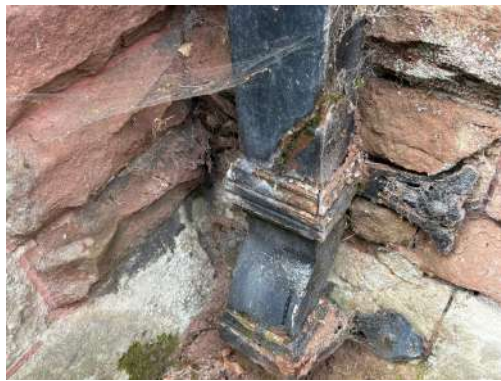
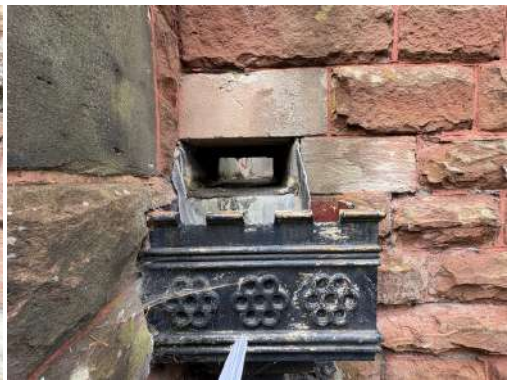
- Choir vestry – downpipes serving flat roof – both have considerable issues but are decorative and attractive in their own right, having particularly decorative hoppers and brackets. The north pipe is unfixed at the base and requires a new bracket. It was also probably blocked at the time of the inspection, as judged by the amount of dampness and staining – it is important that this is cleared. The gulley itself was clear. The east facing pipe was cracked and requires replacement, alongside some of the decorative brackets.

*Choir vestry east- cracked downpipe and outlet into hopper*

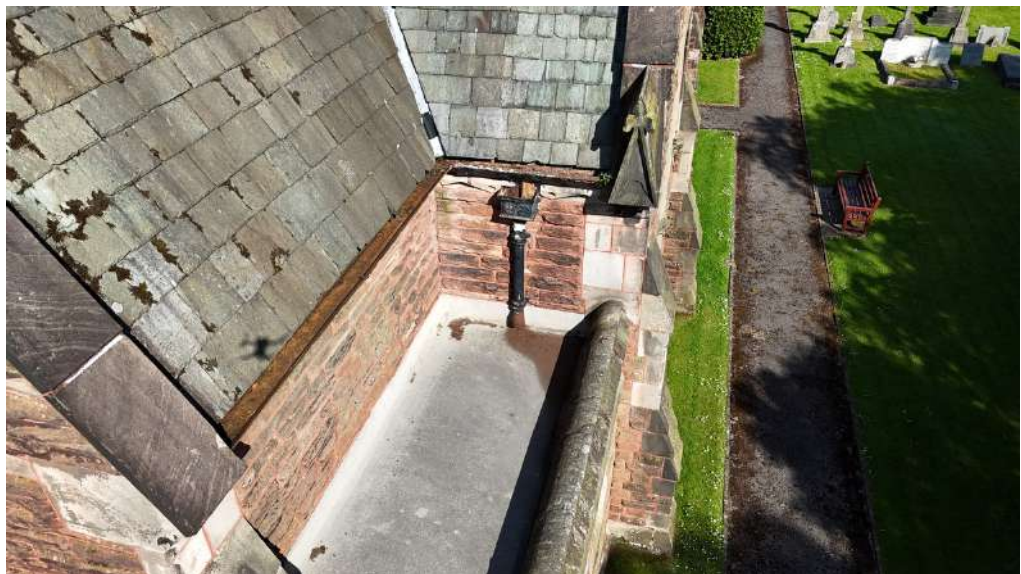
- North transept, east side – guttering assumed original but heavy corroded. Outlet previously described as failing and plant growth in gutter – there is still some vegetation in the gutter which requires removal and staining around the pipe which suggests a previously blocked hopper or leaking outset – this should be checked.

- Organ chamber north side – guttering thought to be later as plain. Heavily corroded. Possibly leaking at left-hand end as very stained underneath – check in heavy rain or with hose pipe.

*Gutter and short downpipe serving the organ and north transepts.*

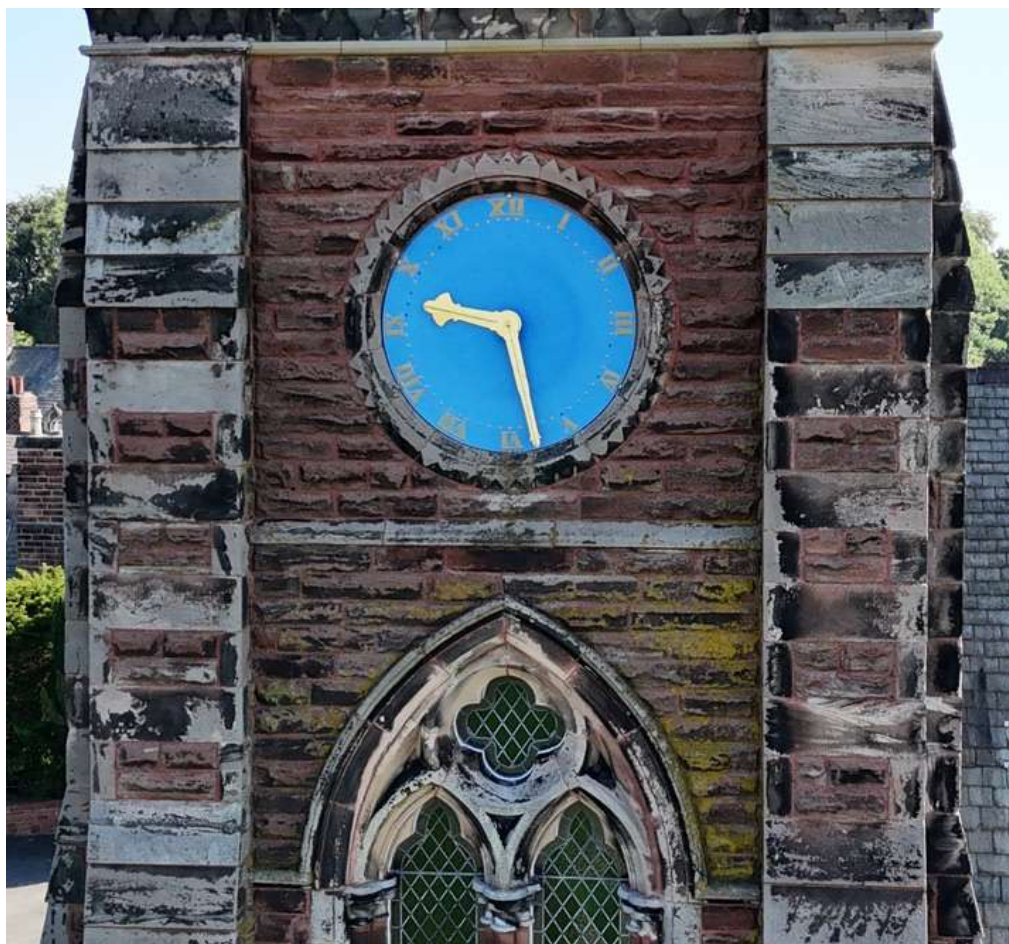
- South side – Recent repair over door. Minor open joints. Algae to right-hand of window. Whilst there is similar degree of wear / failure to the surface of the stone on this side compared to the other exposed elevations (east and west), the impact (i.e. health and safety risk) of falling masonry is higher, being over the main door, therefore it is especially

important to monitor at least from ground level for any changes.

*South side*

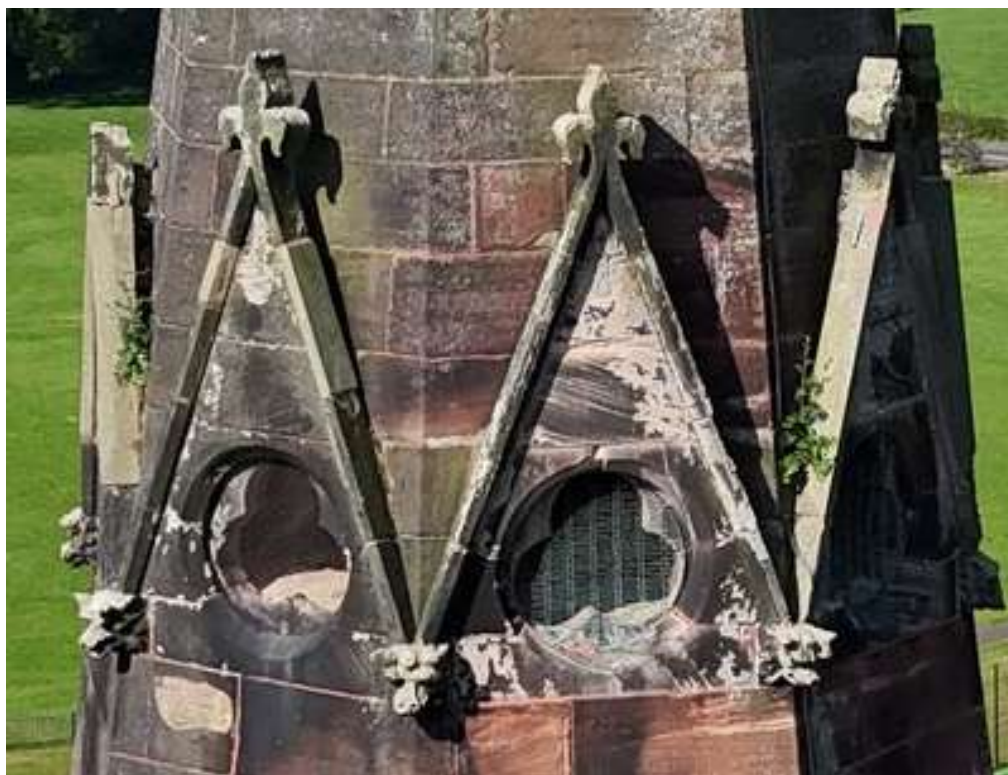
- 3.8.3 The spire is in generally fair condition but is prone to plant growth in places and is subject to being used by birds for perching / nesting which further encourages the vegetation and to a lesser extent wear and tear.

*Plant growth on the north and north-east sides*

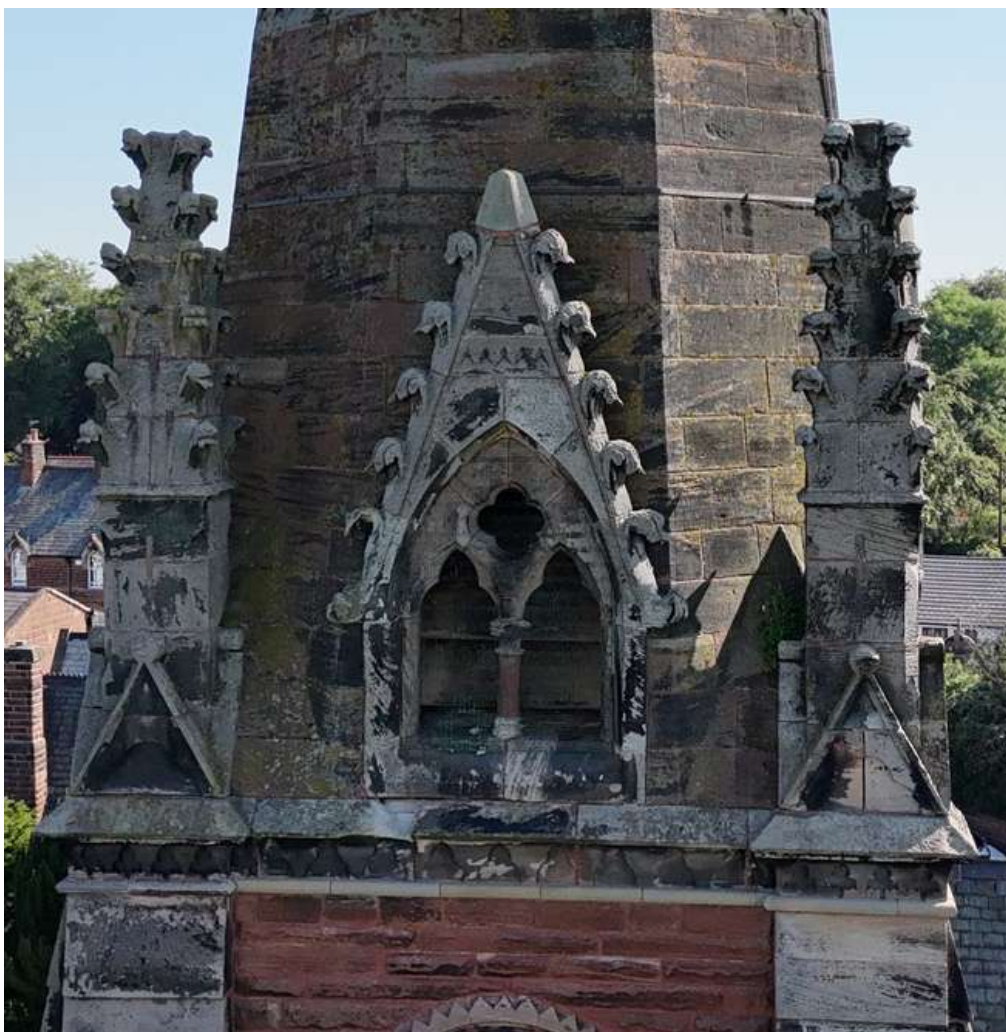
*South side – at the base of the louvred opening can be seen the damaged stone, from which a loose section was removed during the recent steeplejack inspection.*

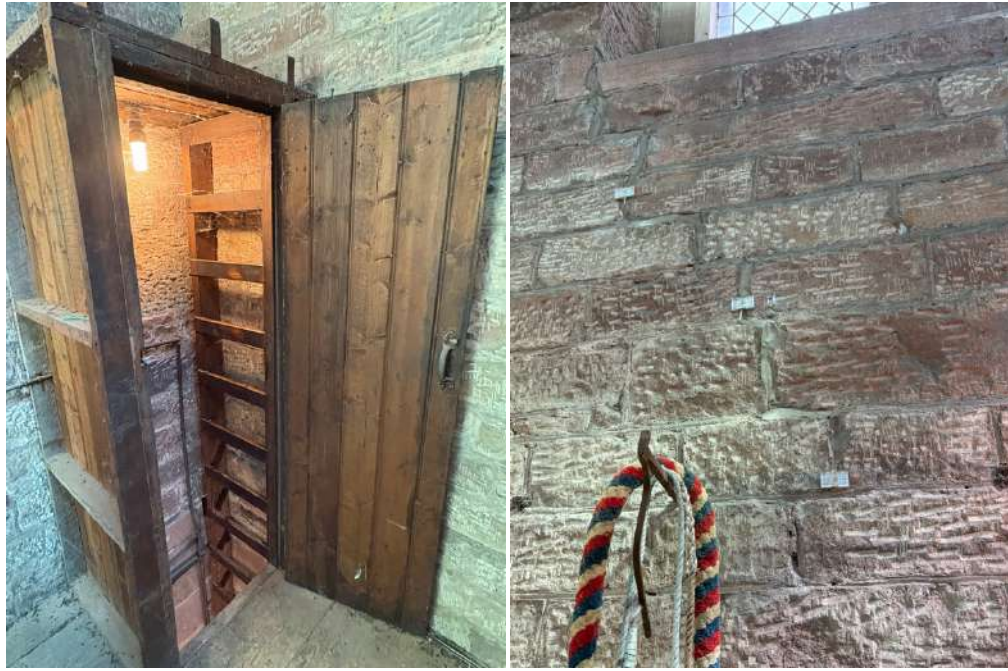
*Sounding chamber – access point and old crack on wall*

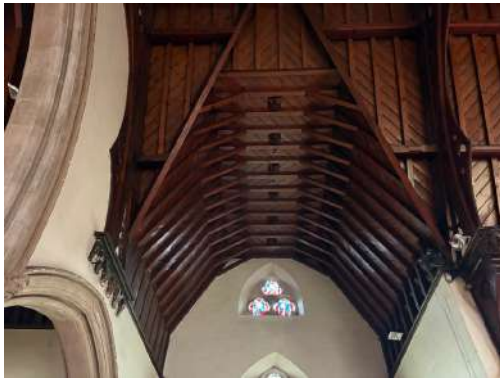
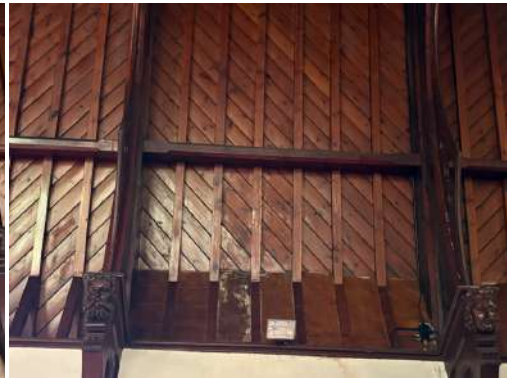
- 4.2.3 There are carved timber bosses on or near the centre line of the ceilings.
- 4.2.4 The condition of the ceilings is generally very good. The previous inspection noted staining in the nave over the purlin from the third bay from the west end on the south side which at the time corresponded to recent water ingress. This is still visible and the church still reports very occasional slight leaks here. The boarding is also stained with the first two bays at the west end on the south side (where the nave abuts the tower) – whilst no leaks were noted, this seems more noticeable than described 5 years ago, therefore this needs to be monitored and action taken if needed.

*Transept ceiling and staining to the south side of the nave*

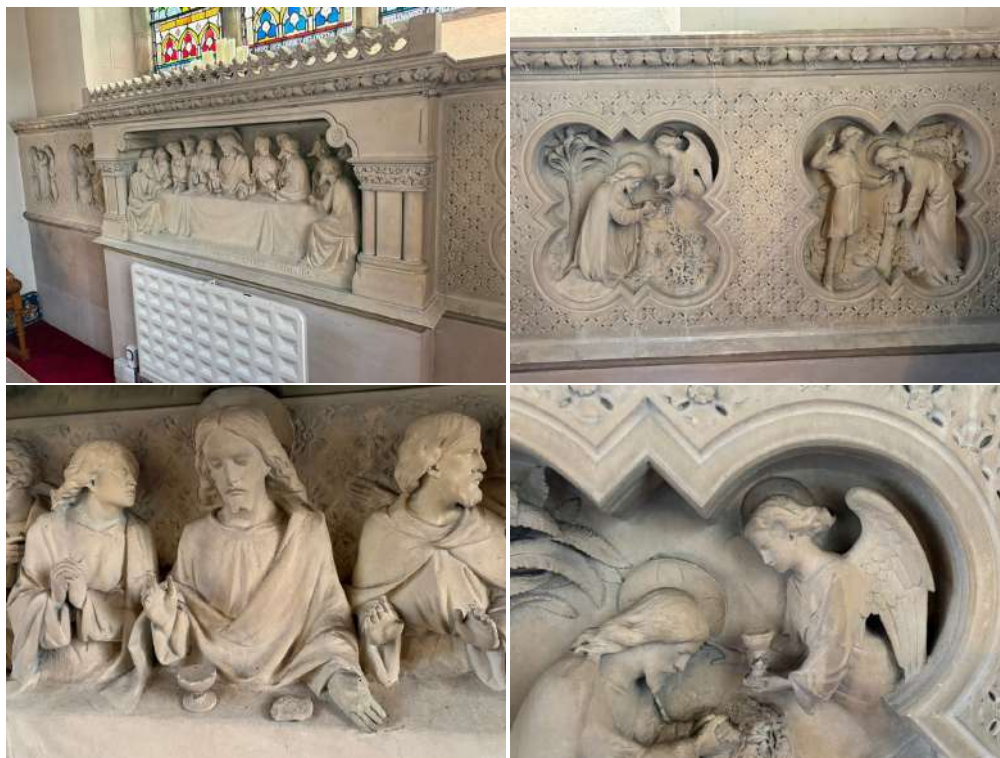
*Reredos – the broken chalice is seen in the final picture*

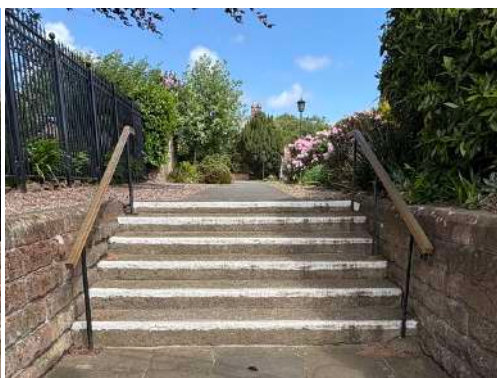
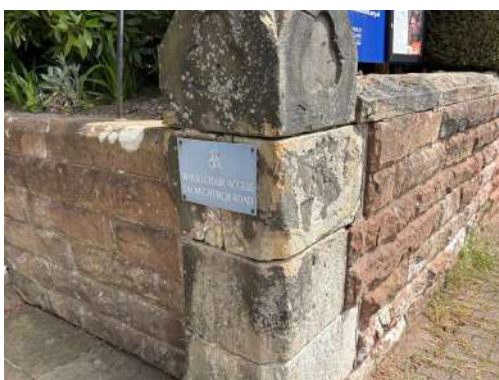
*Damage to southern gateposts*

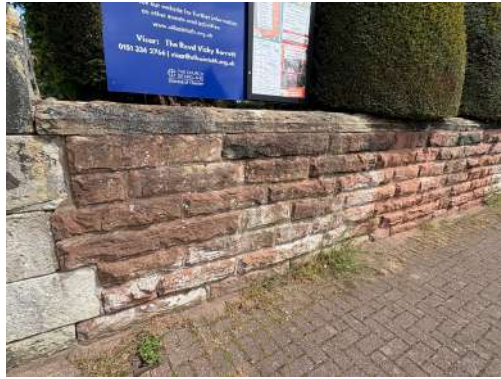
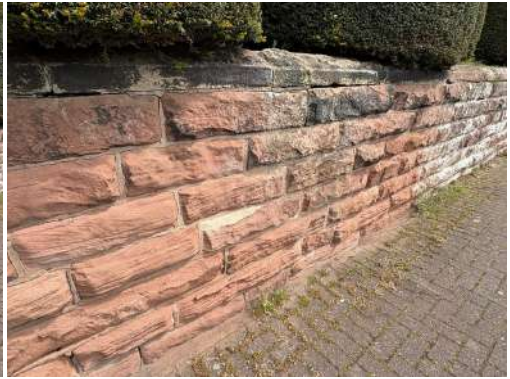
*Areas of cracked and eroded wall*

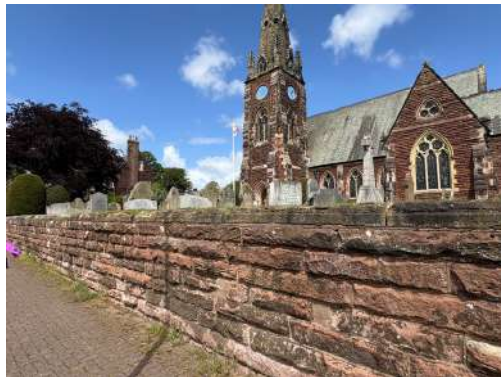
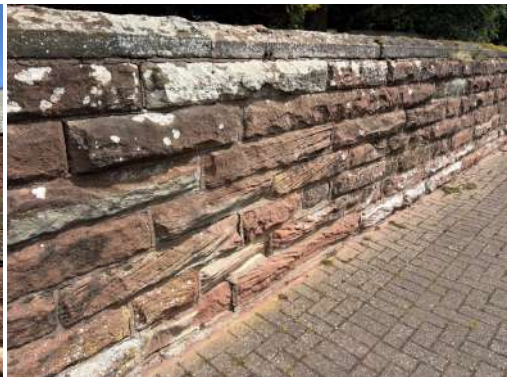
*Area of minor lean and open joints (left) and more significant erosion*
