# ALL SAINTS, THORNTON HOUGH

Quinquennial Inspection

Chambers Conservation Ltd, May 2026 – Issue 2

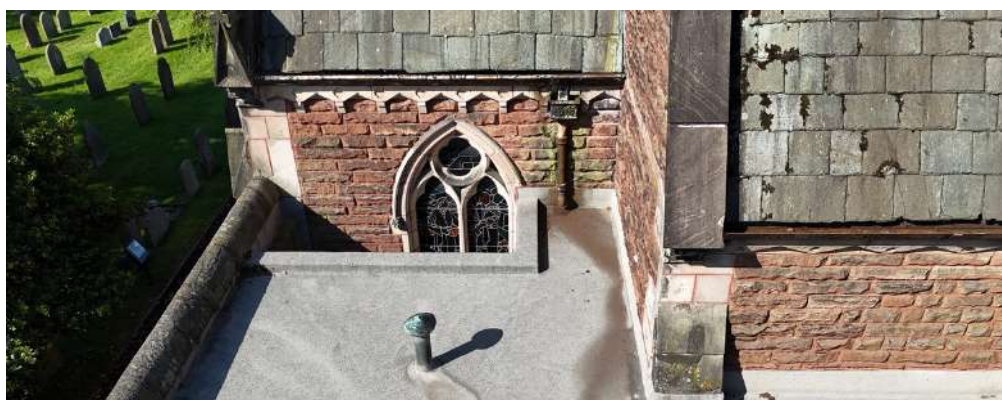
- Chancel, north elevation: Seen only above the choir vestry roof via drone (or ladder). Staining around short section of downpipe suggesting long-term water on the stonework, possibly leaking from the short lead pipe going from the gutter to the hopper. This does not seem to have caused damage at present, however.

*North side of chancel viewed above the choir vestry*

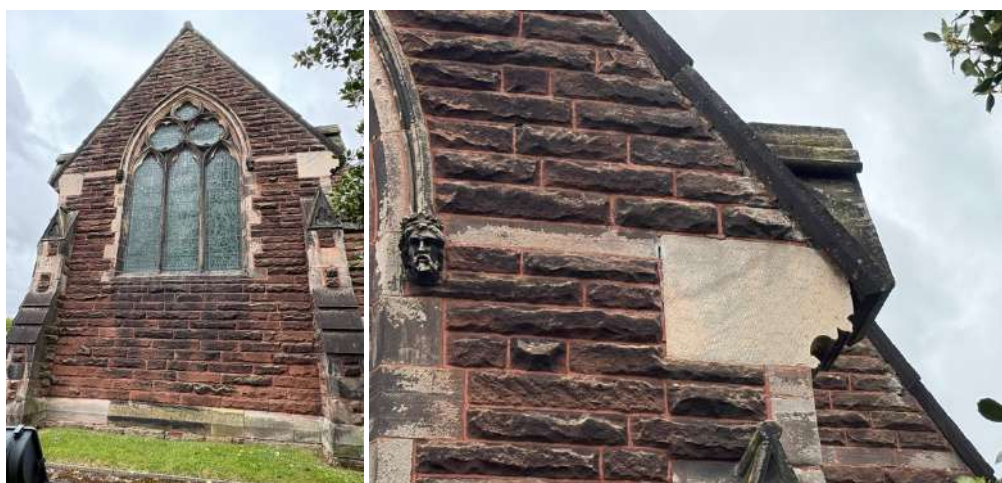
- Chancel, east elevation: The coping stones remain quite irregular, with mortar missing from both the underside and face. The apex stone also remains higher, implying there might be rusting metalwork securing it, although this has not worsened. The pointing is cracked but intact, except to the base and occasionally at higher level, e.g. around the kneelers.

*Chancel east side*

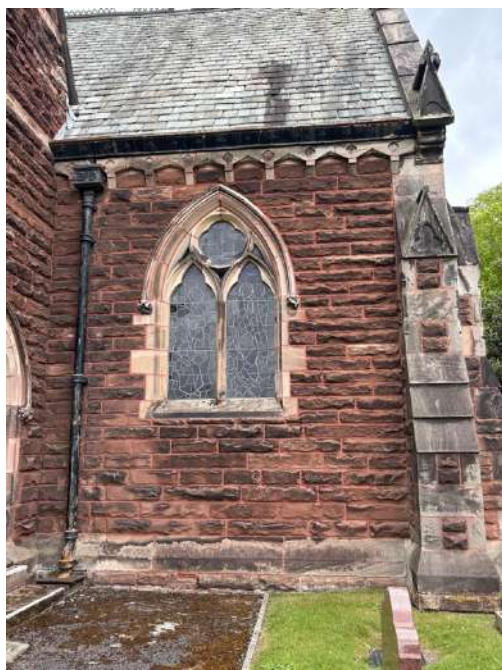
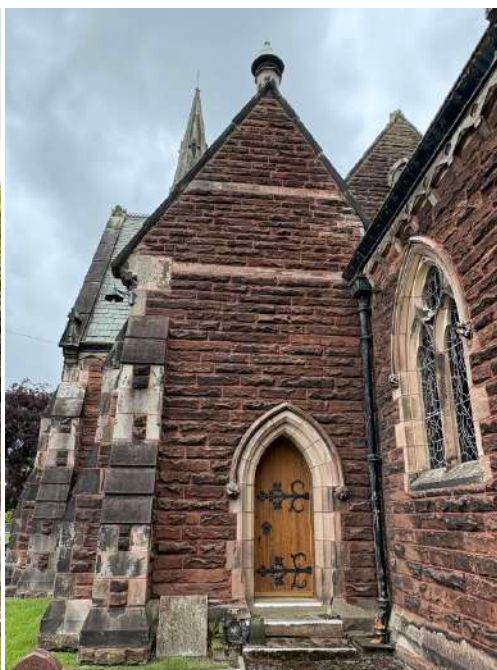
- Chancel south elevation: Mortar generally cracking but no major issues
  - Clergy vestry: Open mortar joints under the coping but otherwise pointing in fair condition (despite being hard and modern). At the apex of the gable is a chimney flue that has for some time been temporarily repaired with flashband.

*Chancel south and vestry east elevations*

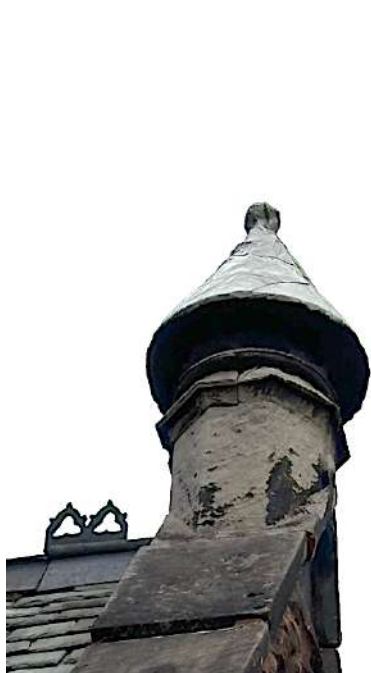
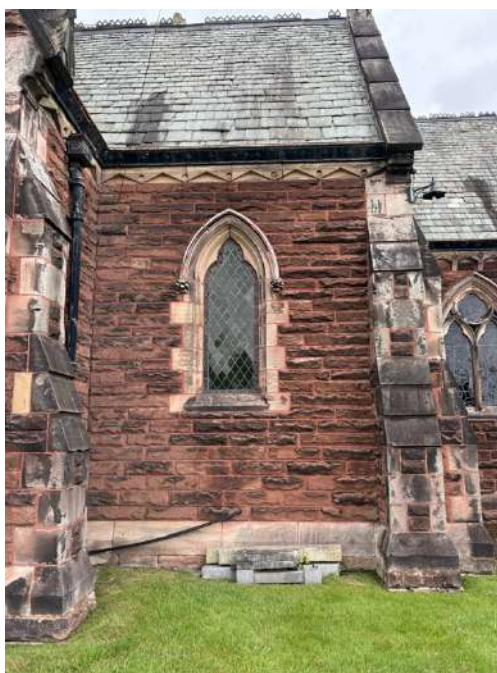
*Vestry chimney and south elevation*

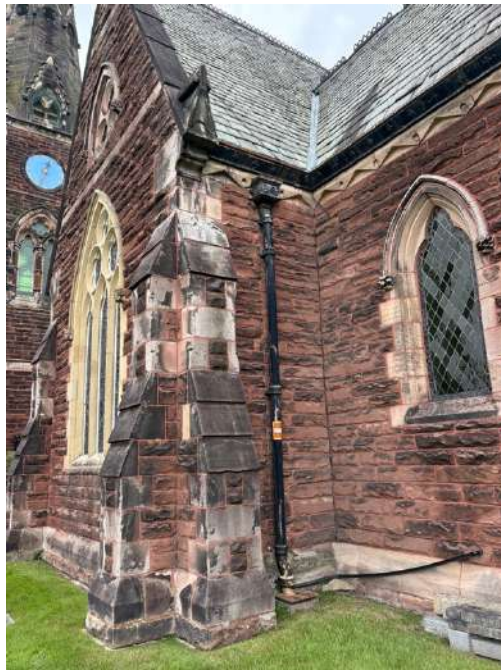
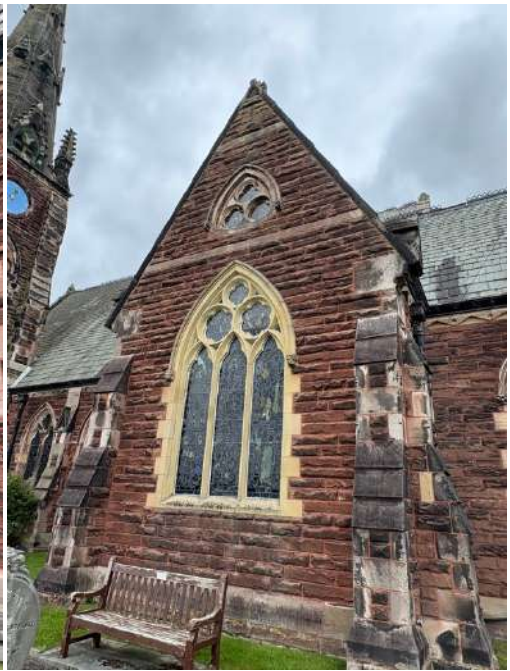
- South transept: Again, the pointing is cracked but generally in fair condition, except under the coping. There is still staining to the corbelling beneath the guttering to the west side (but not apparently wet)

*South transept east and south sides*

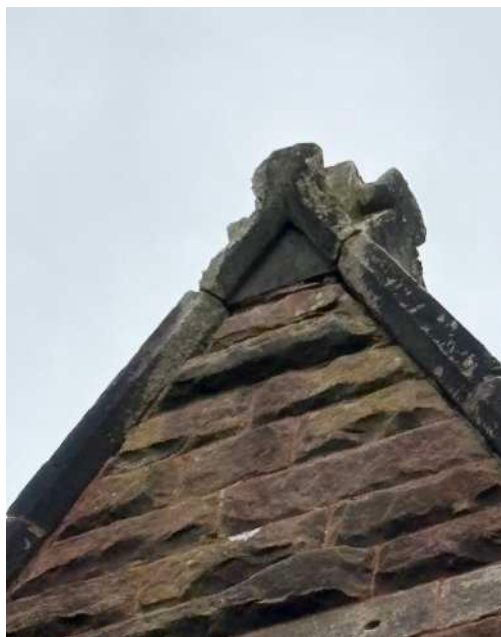
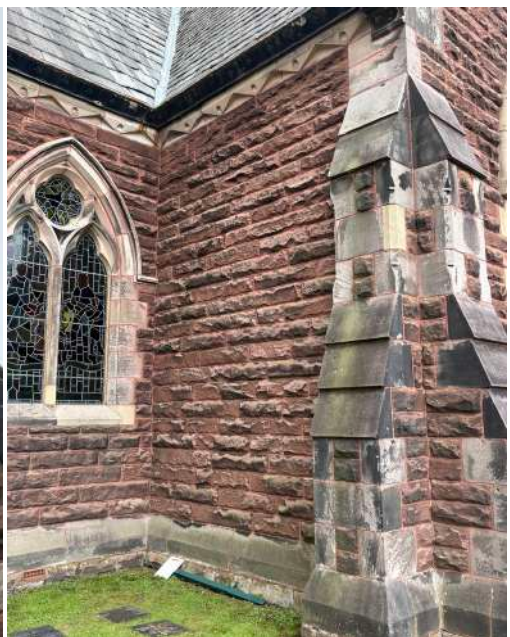
*South transept gable apex stone and west side*

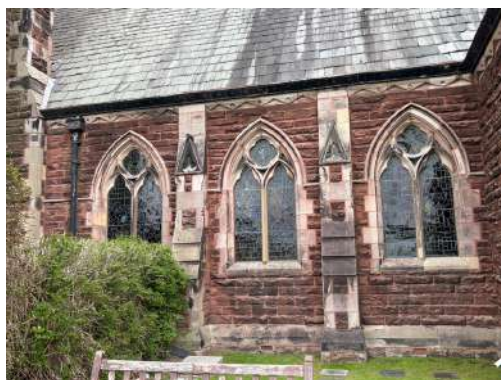
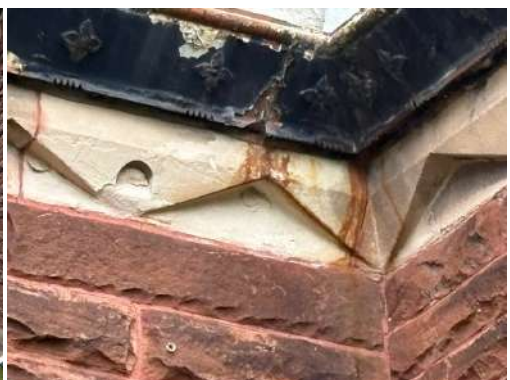
- Nave south elevation: Again, the mortar is cracked but otherwise intact, generally except open joints noted at the base. The church wisely keeps the vents serving the under-pew voids clear. Staining under the gutter to the corner abutment with the transept is slightly better to previously. Equally, the staining around the west cast iron downpipe is improved.

*South nave elevation*

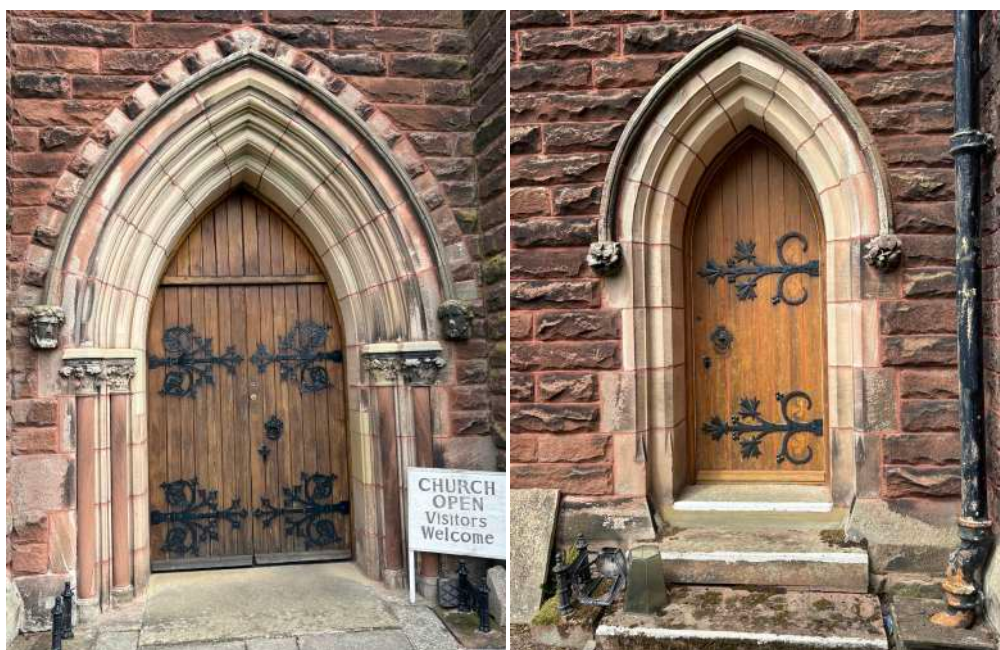
- Tower south door (main entrance): Vertically boarded with highly decorative strap hinges. Deep ornate carved stone archway. Door sound. Staining to stone from modern coloured mortar.
- Vestry door: Vertically boarded with highly decorative strap hinges. Ornate carved stone archway. Door sound. No handrail to steps.
- Choir vestry door: Flat lintel boarded door-less decoration to strap hinges but nonetheless attractive. Door sound. No handrail to steps.
- North door: Vertically boarded with highly decorative strap hinges. Deep ornate carved stone archway (slightly less so than south side). Door not tested but previously reported to snag on floor.

*South main tower door and vestry door*

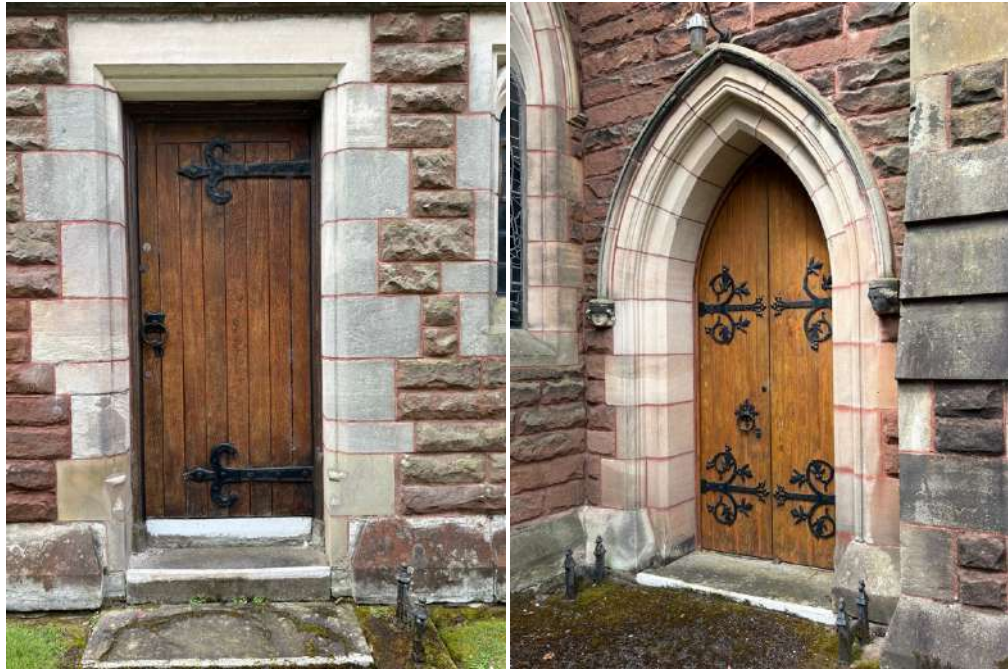
*Choir vestry door and north porch door*

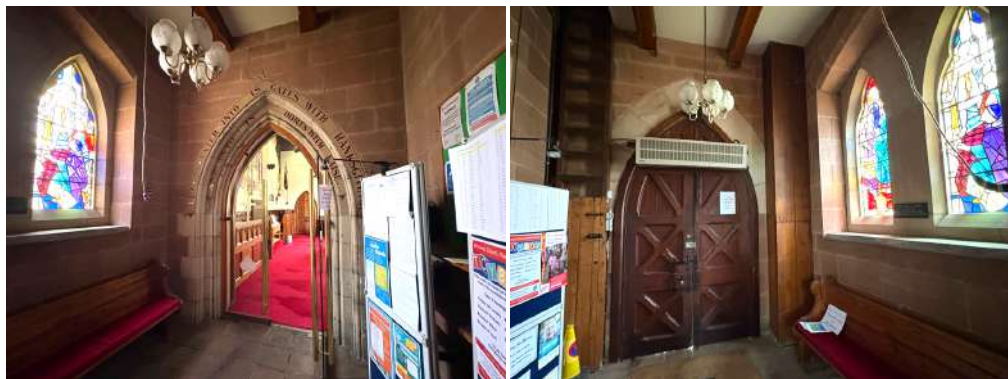
- South porch – at the base of the tower, forming the main entrance to the church. The area is a welcoming space and includes free-standing noticeboards. It also has a vertical ladder leading to the tower (which is wisely protected by locked doors at lower level) and a bell rope loosely tied to the wall. The floor has large clay tiles, which are generally sound, although the pointing is failing slightly. Walls are exposed sandstone and are generally in good condition – one exception is the north wall, which has an old stepped crack (not of current concern).

*South porch*

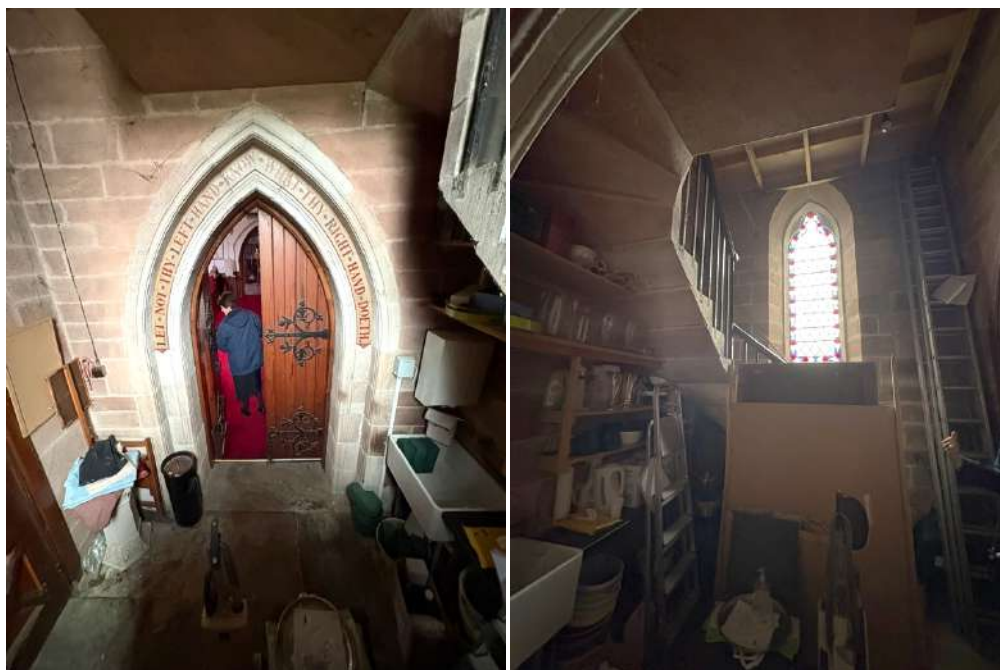
- North porch (also known as the flower vestry): this space is not well used, other than primarily for storage of cleaning equipment and by the vergers. It has a stone flagged floor and exposed stonework to the walls. The ceiling is modern and relatively crude, but this is not important with the existing level of usage. There is a stair from this area leading to an upper storage room (mentioned elsewhere). The previous report highlighted water staining to the junction of the north and east walls – this seems to have improved. The external door is a designated emergency exit, so it is important that the space is kept as clear as possible.

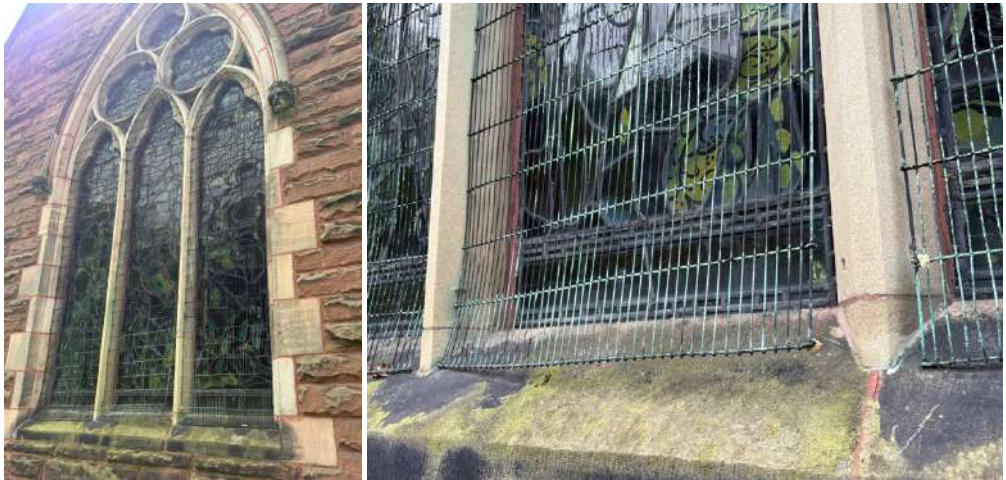
- North transept – window protected with copper wire guard. The bottom does not fit well and is a result pulling away – this should be refixed.
- Choir vestry north – mullion to the double window previously noted to be eroding – this has not worsened significantly.

*North transept, north window*

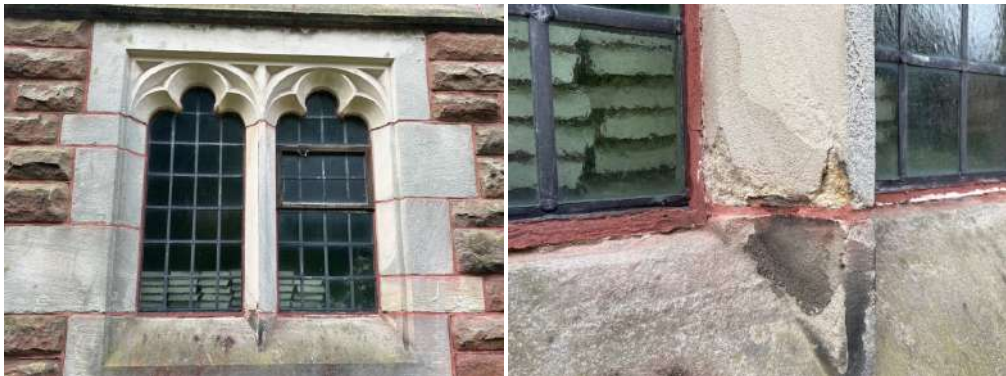
*Choir vestry, north window*

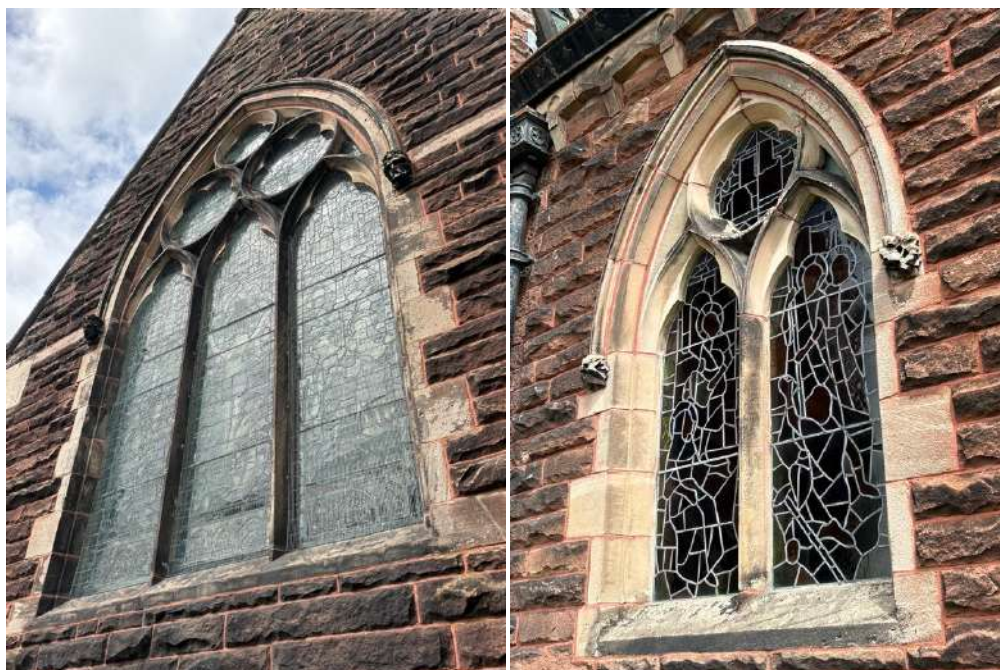
- Chancel east – triple window protected by a copper wire guard. Open mortar joint to the cill.
- South transept, south – window tracery fairly modern
- Nave south, right-hand window - various stone replacement in recent decades (including half of cill and base of mullion).

*Chancel east and south windows*

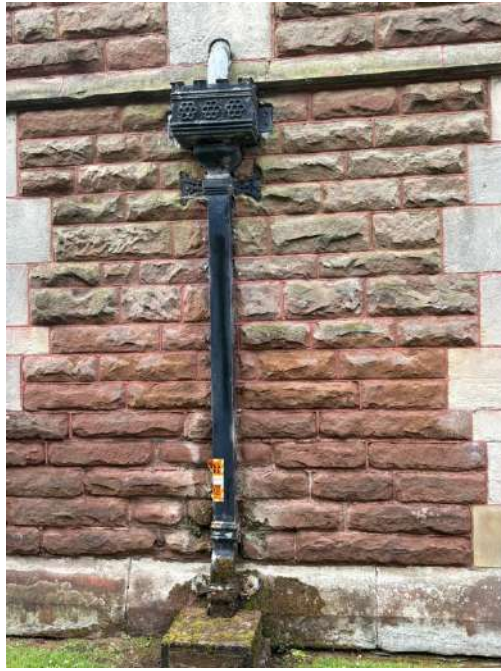
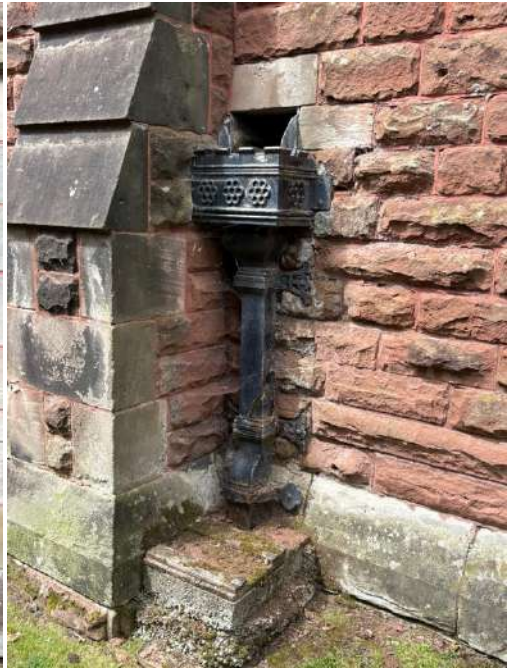
- Choir vestry: the mortar, together with dampness from the downpipe and roof is causing the saturation of the stonework and its gradual degradation. This will be worsened by it being shaded and north-facing. Visually, the pointing is failing dramatically in appearance, although this is largely the superficial later mortar falling away. This area should be a priority for repointing after rainwater goods issues are fixed (included elsewhere).

*Choir vestry downpipes on north and east sides*

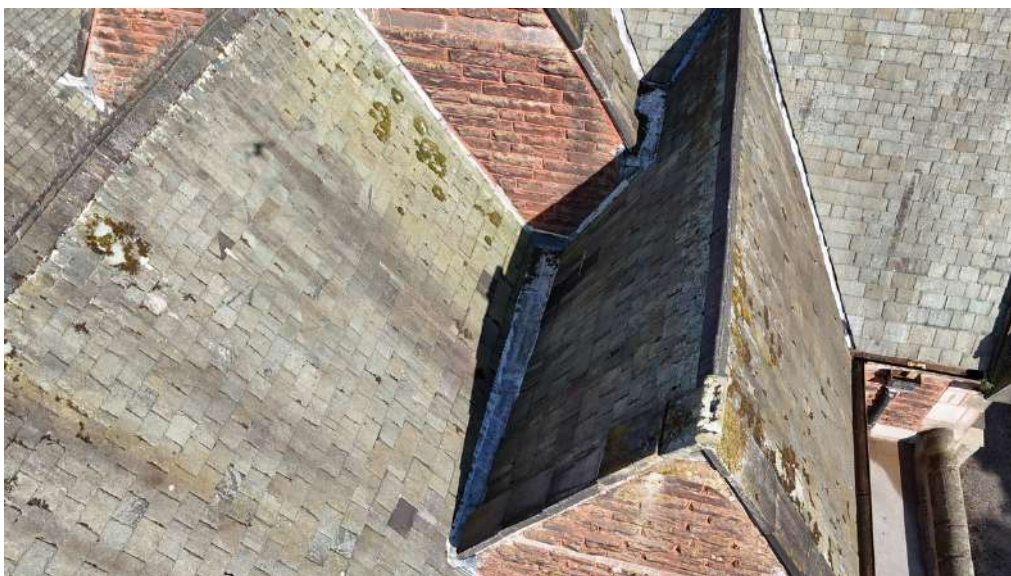
*Vallet gutter between the organ transept and chancel*

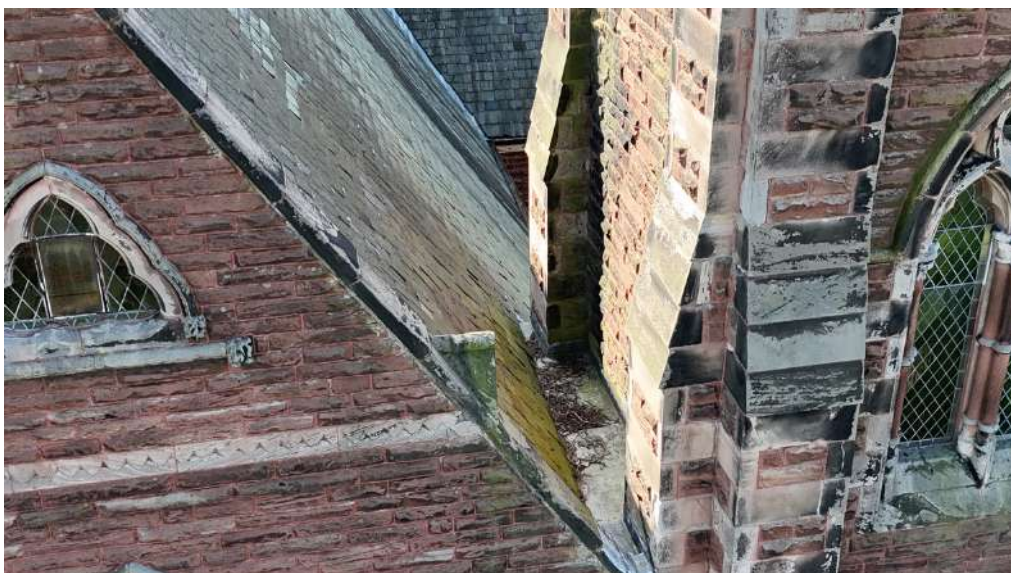
*Lead gutter between the tower and south nave roof*

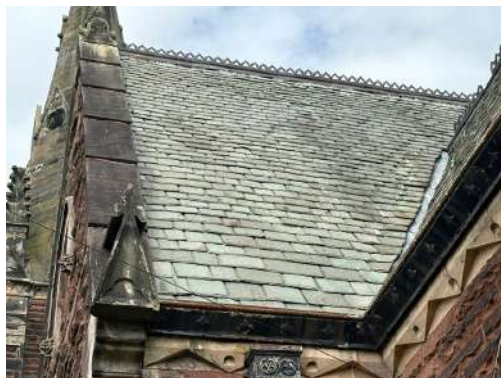
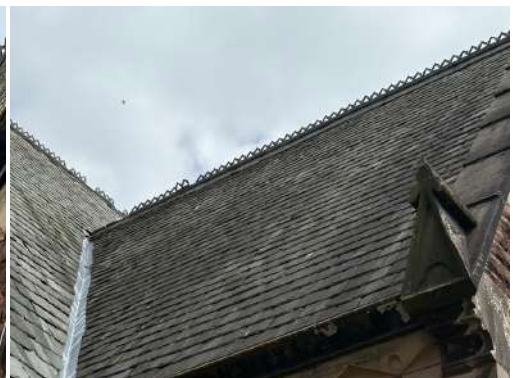
- South transept east side – Roof slope appears uneven and there a quite a large number of temporary repairs, particularly near the valley gutter shared with the clergy vestry roof. There are large gaps under the ridge tiles – this is presumably caused by birds or bats, therefore no action currently advised but it is important to monitor it for water ingress. Some damage to a few ridge tiles.

*South transept roof*

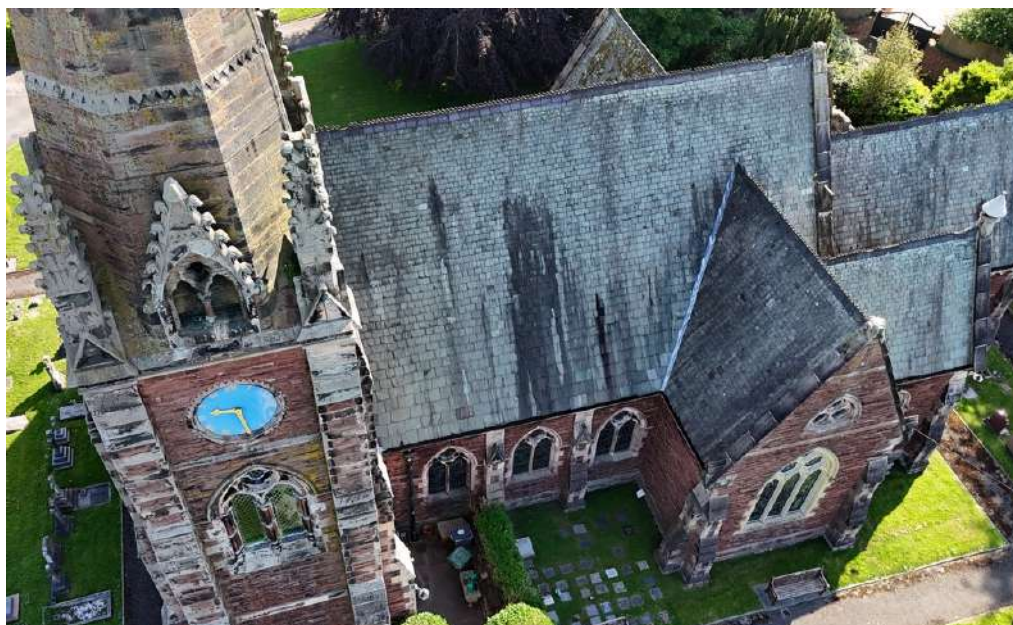
- South transept west side – As previously - Generally better than the east side but still a number of temporary repairs.
- Nave south – Condition relatively poor, but apparently not worse than 5 years ago. Roof repairs reportedly carried out 10 years ago following water ingress. Lead and copper tabs over roof (20 or so) – there is a bad patch of current damage halfway up, approx. 1m in from south transept abutment – it is important that this is dealt with, together with a slipping slate at the bottom. There are quite a few damaged slates on the roof.

*South nave roof*

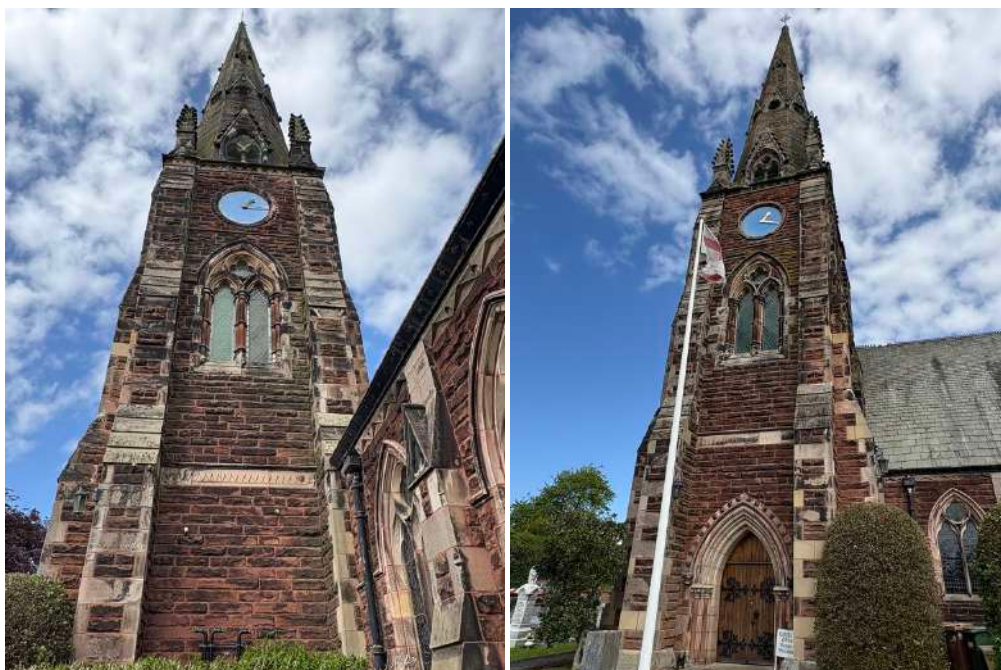
- South side – Recent repair over door. Minor open joints. Algae to right-hand of window. Whilst there is similar degree of wear / failure to the surface of the stone on this side compared to the other exposed elevations (east and west), the impact (i.e. health and safety risk) of falling masonry is higher, being over the main door, therefore it is especially

important to monitor at least from ground level for any changes.

*East and south sides of the tower*

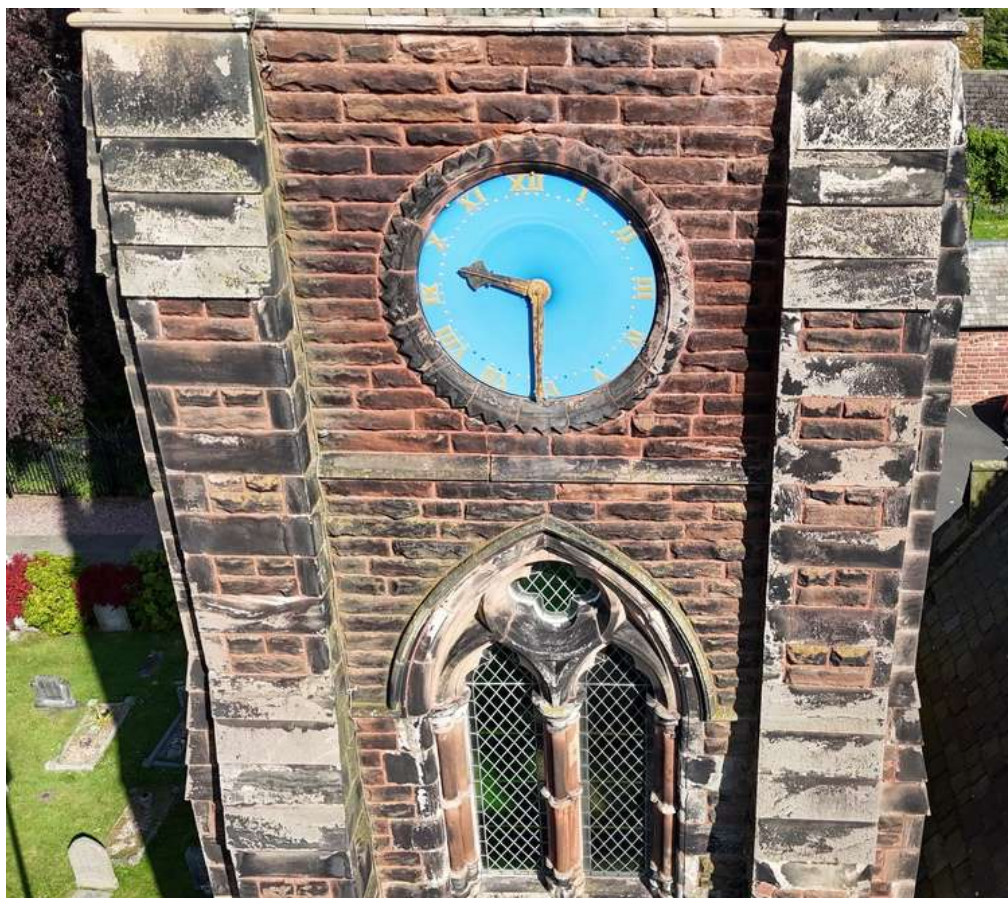
- 3.8.2 Notes on the external fabric of the main body of the tower are as follows:
- East side – Open joists to window cill and right-hand buttress. Slight degradation to surface of stone.

*East side*

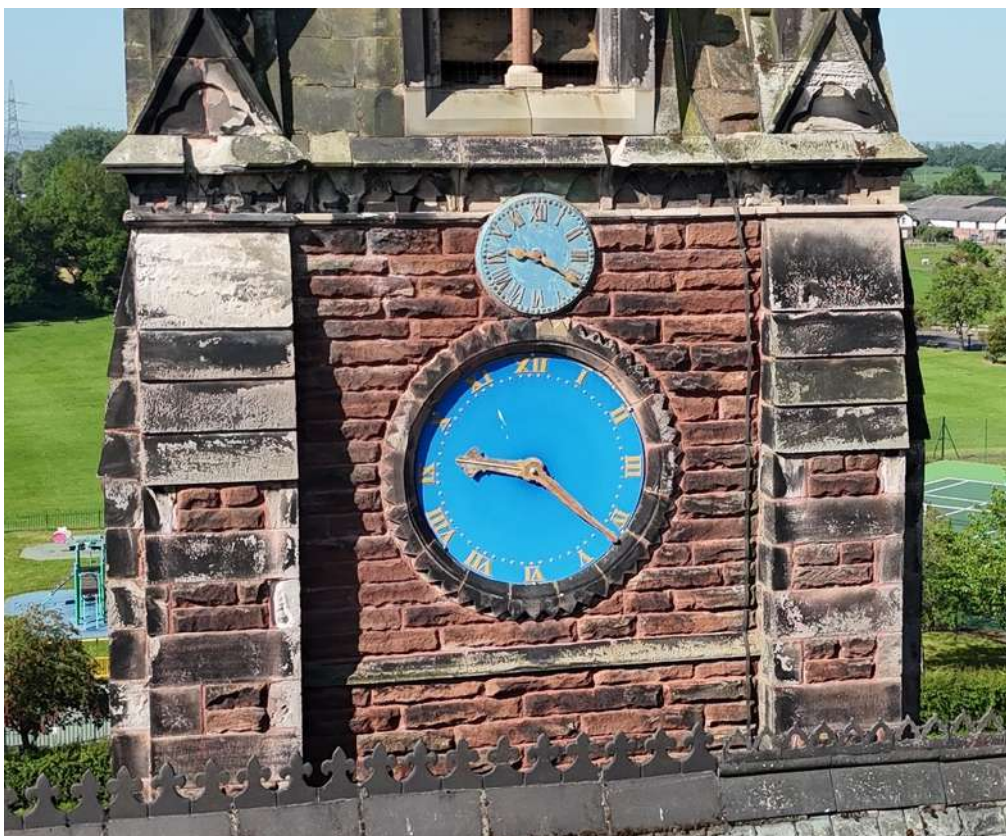
- North side – Small section, seen above nave roof. Generally sound – some failure of surface to stones on buttresses.
  - West side – Crack to cill of window (not worsened since last report). Some degradation to clock surround and face itself.

*North side*

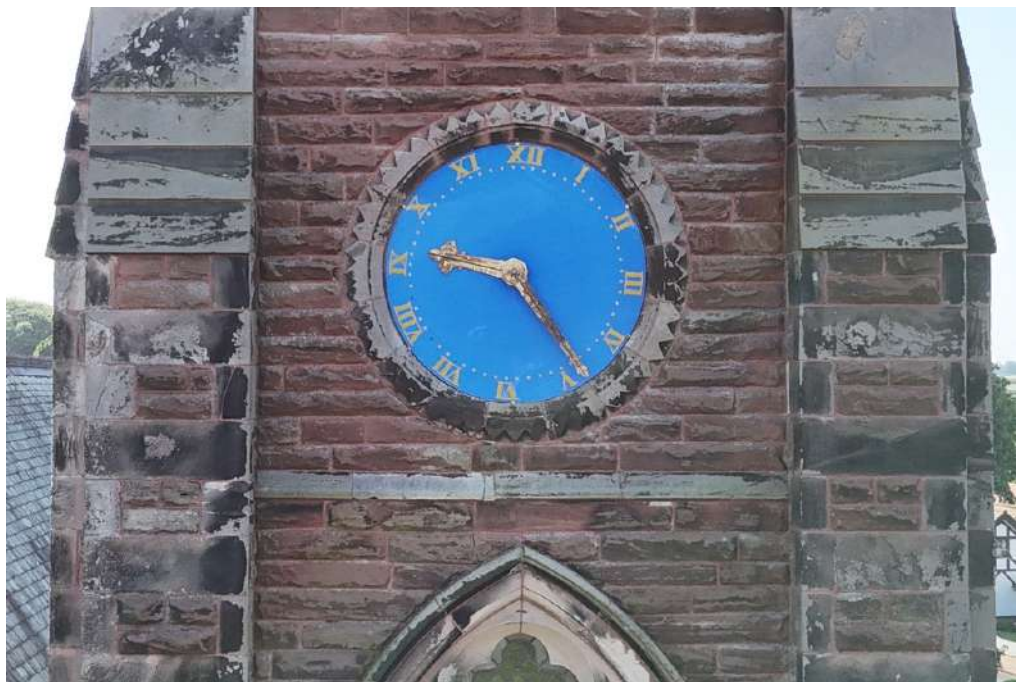
*West side*

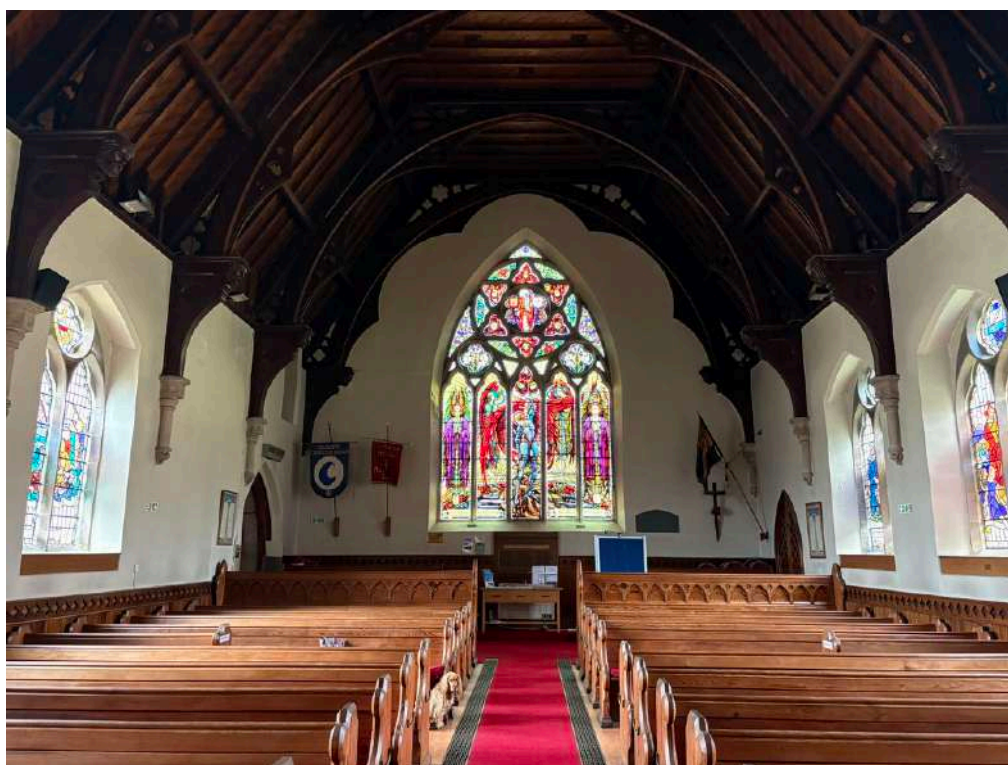
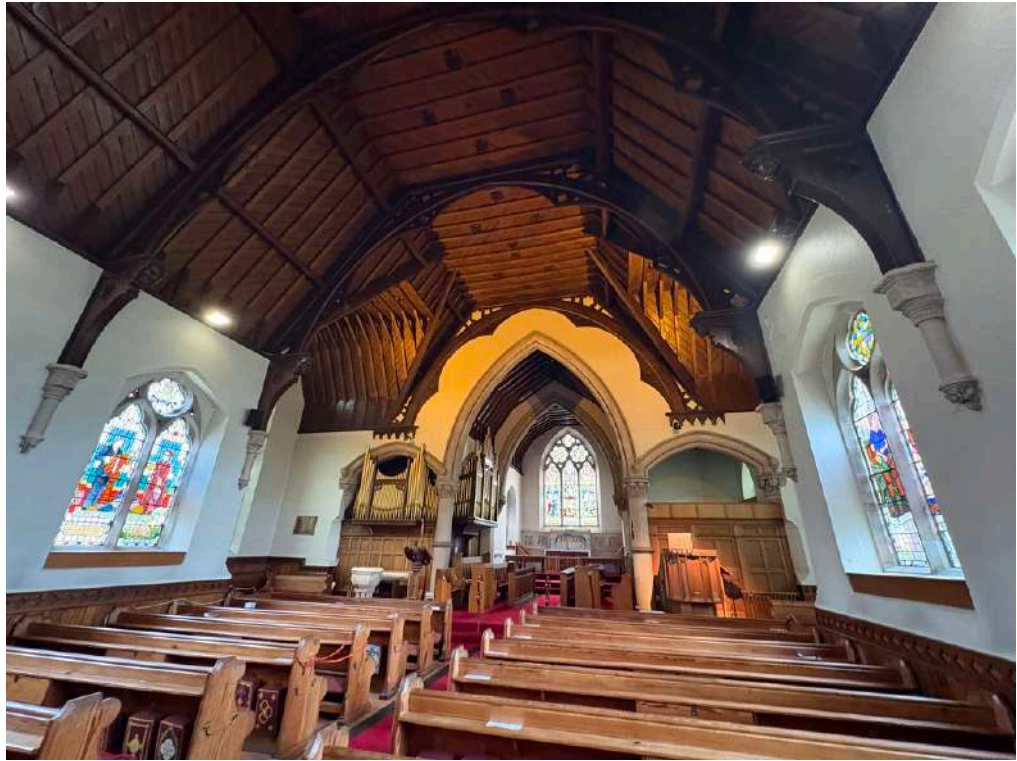
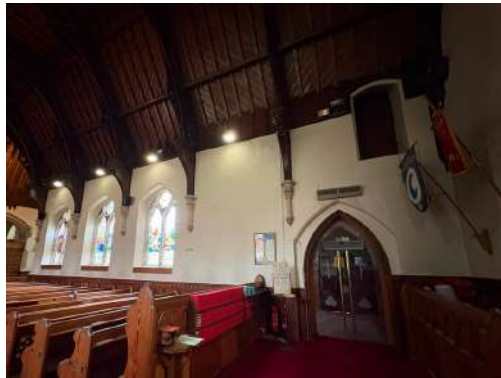
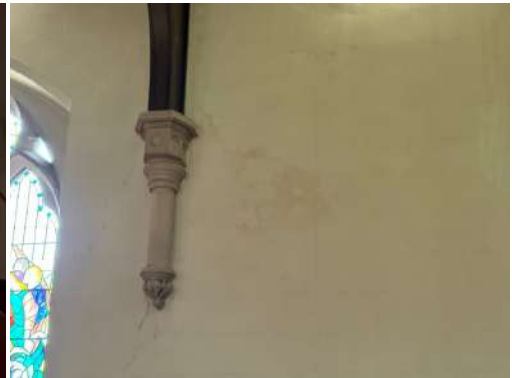
- Nave - Water staining remains to second bay from the west on the south side (from the tower abutment gutter (area of ceiling too as previously described)).
- South transept - Slight water staining and blistering to the corner of the south transept (noted in previous inspection). This has obviously been a long-standing issue as the plaster has clearly been renewed preciously. (External signs do not seem to indicate this is a current issue, so this could be redecorated after a short period of further monitoring. Slight cracks were noted, but these are not of concern currently.
- Chancel – slight cracking note – not of current concern. Slight staining to rear of chancel arch. There is an oak partition forming the wall to the clergy vestry – this has a small extension vertically which is not quite of the same high quality as the original fabric.
- North transept – no significant issues

*South wall*

4.6.1 The internal walls are plastered and generally scored to imitate stonework. Where issues are noted below, it is worth leaving areas to dry fully for a year or more before considering repainting or plaster repair:

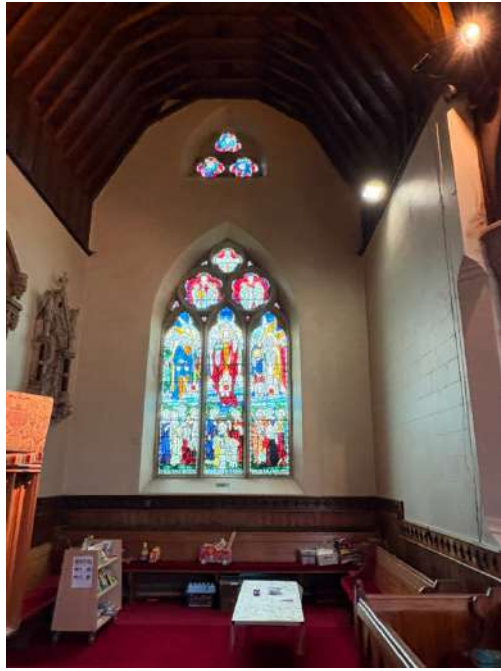
*South transept*

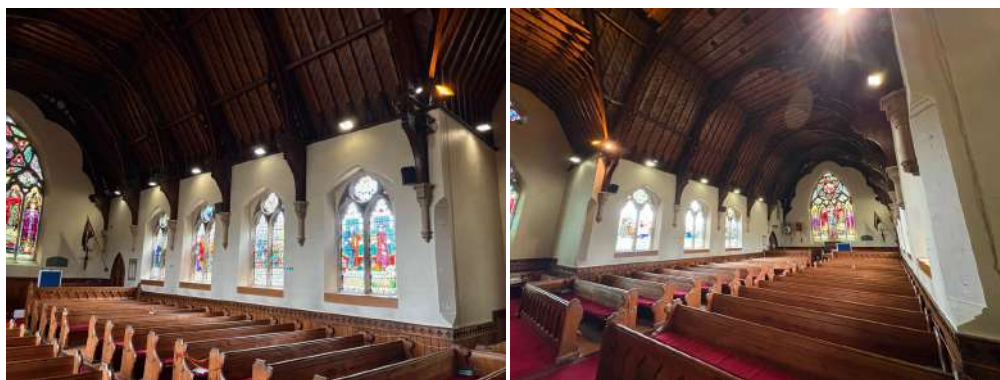
*North side of nave and general view looking towards the west end*

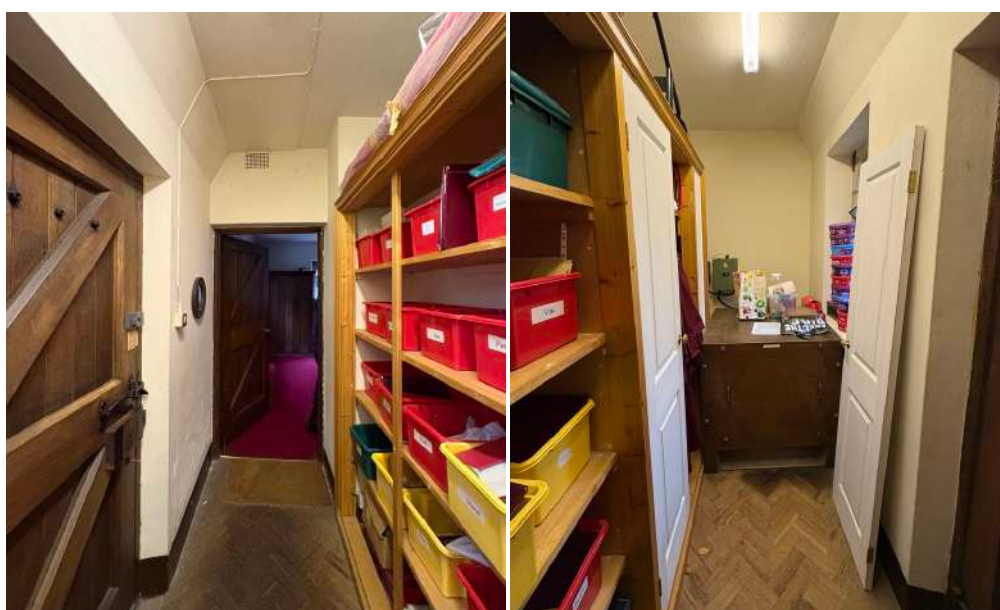
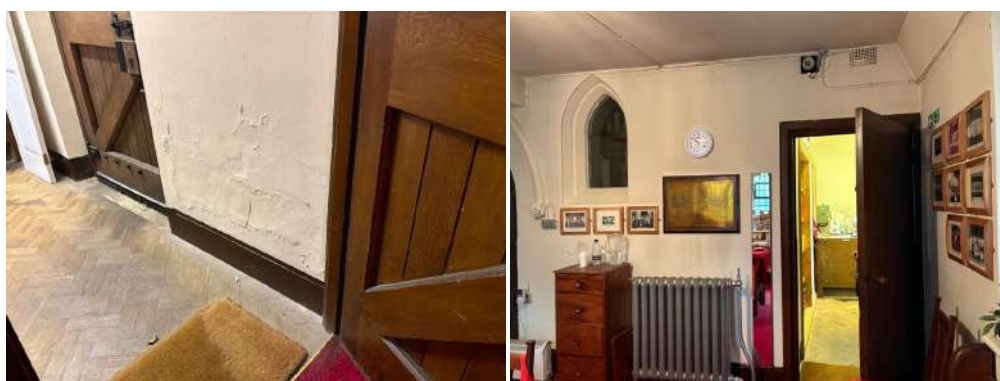
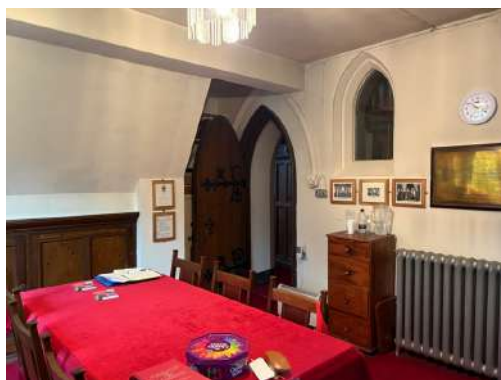
- 4.10.2 The choir vestry has painted plaster walls – it had a musty smell at the time of the inspection presumably as a result of the dampness of the external walls (discussed elsewhere). It is still used for the choir as well as for counting the collection. Slight cracking was noted to the plasterwork. To the small porch / corridor leading to the external door (at the rear of the organ), the plasterwork was blistering / damaged at low level – this corresponds directly to the problematic area externally around the downpipe. Once the external areas are dealt with properly, this area will probably need replastering. In the meantime, internal doors should perhaps be left open to encourage ventilation and drying out of the space.

*Choir vestry*

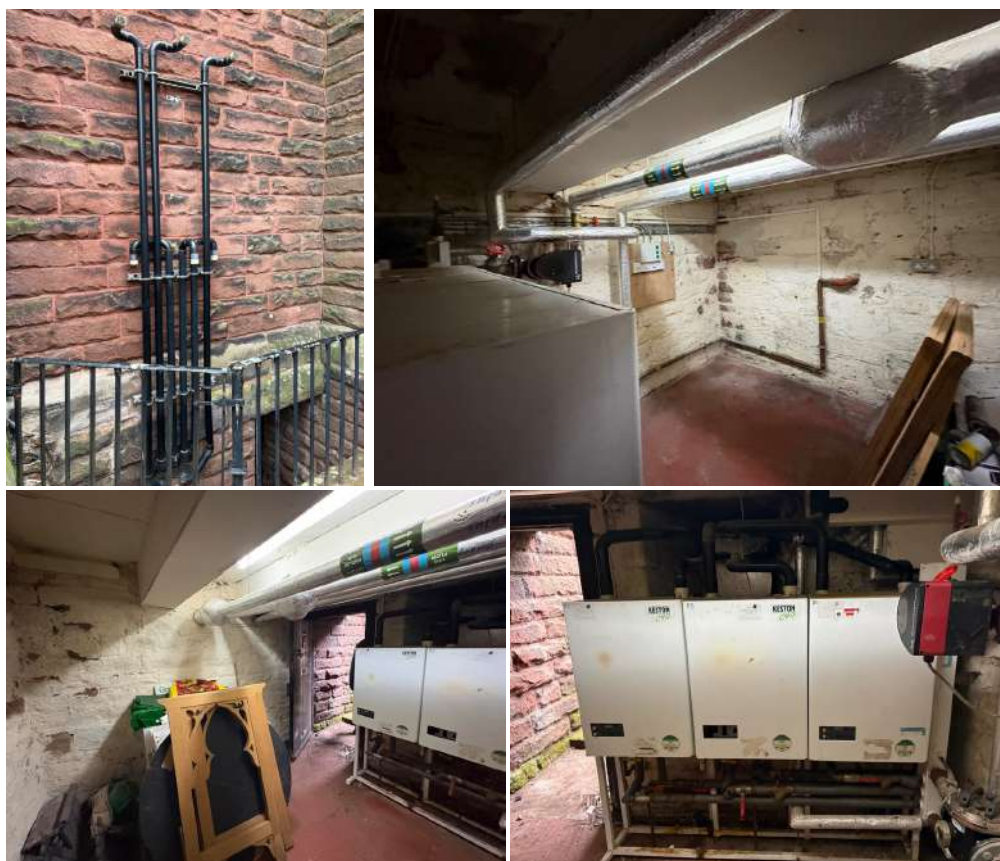
- 5.1.1 The church had been experiencing issues for a while with the existing system – the final working boiler failed at Christmas 2025. Since that time, heating has not been functioning since despite attempts at repair. Each of the three boilers has now failed and parts are not available.
- 5.1.2 At the time of the inspection, the church had commissioned an independent heating report – it had recommended a hybrid system, but the church had not found this to be affordable, particularly in the light of other repairs that were needed to the building. Other options raised, such as infra-red heating or pew heaters, were not viable do to the configuration of the church.

- 5.1.3 The church has been taking regular heat and humidity readings which will be useful in proving the need or otherwise for background or higher levels of general heating. The vestry has reportedly become more damp as a result of the heating failure – papers and robes have become musty smelling. Also, doors have been sticking. It is suggested that running a dehumidifier is a fairly economical way of making improvements to internal moisture levels (particular to smaller spaces) whilst awaiting repairs to the heating system and building fabric.
- 5.1.4 The existing (now redundant) gas boilers are housed in the boiler room, which is accessed from steps in the corner externally between the south tower and nave wall. As access is needed frequently, the steps are wisely kept swept. The space itself is relatively clean, dry and spacious.

*Existing boiler room and flues above the existing steps*

[Between the time of the inspection and issue of the report, the church has applied for an interim faculty, and the DAC has recommended approval for a replacement gas boiler].

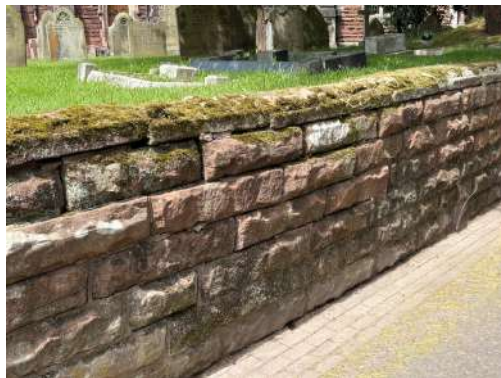
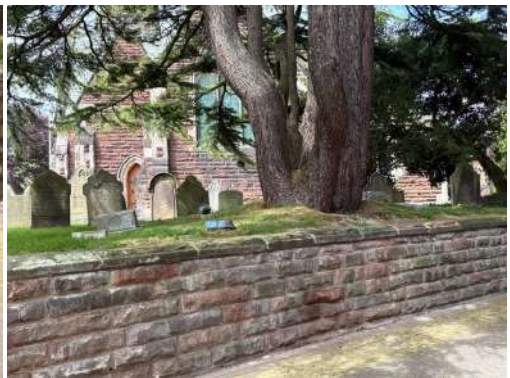
- To the Church Road boundary, the first section of wall is slightly bulging at the top.
- Under the large Cedar tree is the area of the wall that was rebuilt following the most recent collapse -it includes a new foundation, blockwork inner leaf and drainage. The church had been actively monitoring the state of the bowed section of boundary wall and identified that this had significantly deteriorated in January 2025 due to the bad weather. A faculty had been submitted for its repair but after months of information gathering, expert input and research, the church was in the 28 day public notice period in September 2025 when the wall collapsed, resulting in a more complex scheme of rebuilding – e.g. necessitating a complete road closure.

*Church Road boundary wall – the right-hand photo shows the rebuilt section*

- 7.4.2 It is important that the church allows funds for the routine patch pointing and repair of the boundary wall.

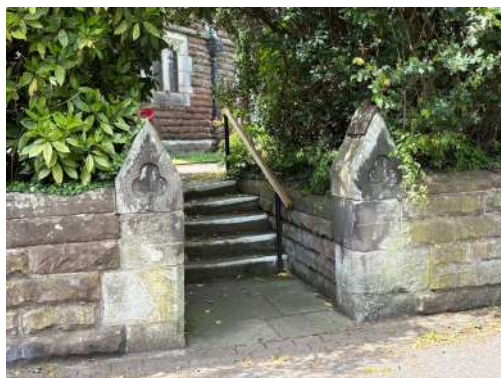
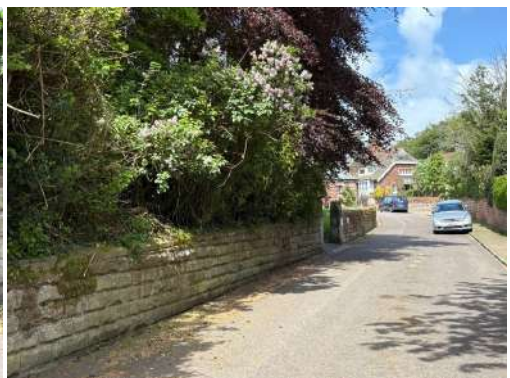
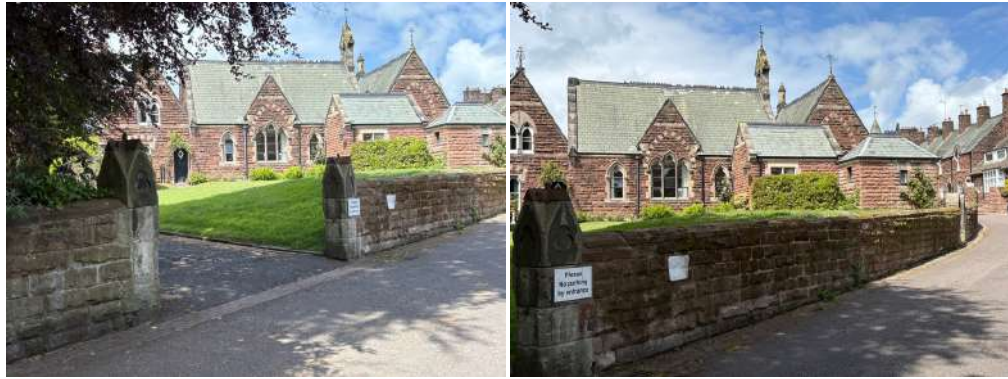
- On the northern side are two further sets of gate-posts – one for a pedestrian and one for a vehicle entrance. No issues were noted. The walling to the part is lower, and generally less vulnerable, although a section nearer the church hall also collapsed and needed rebuilding.

*Northern boundary – the final photo shows a further section rebuilt in the quinquennium*
