# ALL SAINTS, THORNTON HOUGH

Quinquennial Inspection

Chambers Conservation Ltd, May 2026 – Issue 2

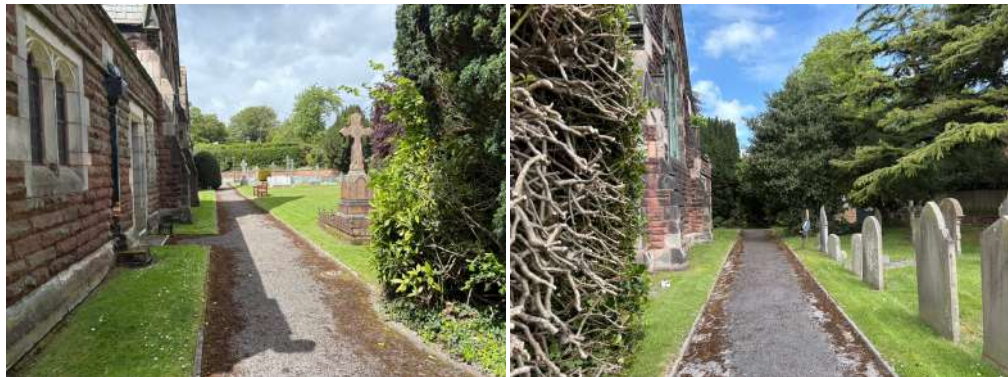
- 7.5.2 Whilst generally well maintained, some of the paths are very slightly uneven with some vegetation growing. There are some cracking and moss to the less used asphalted paths. These should be checked regularly to avoid trip hazards and kept as clear as possible to avoid the surfaces worsening.

*Paths to north and east sides*

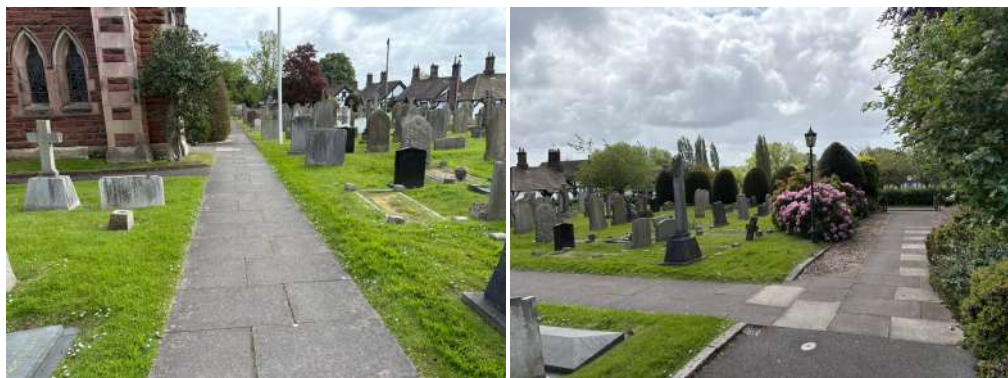
*Main entrance paths from car park and road*

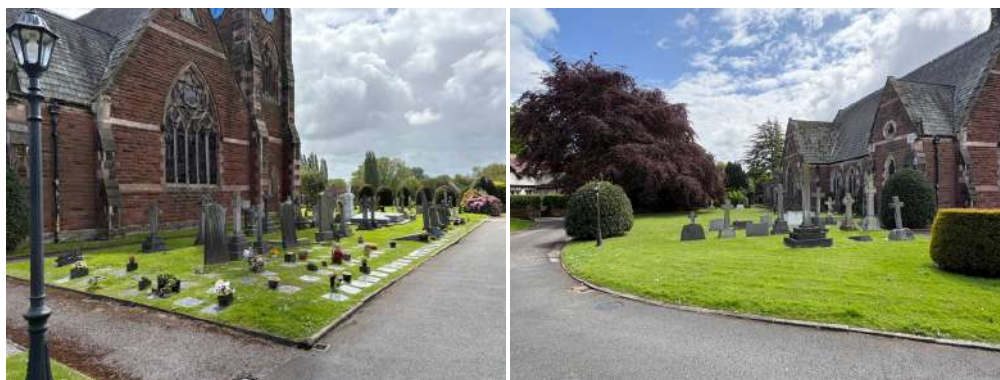
*Memorials / burials areas to the west and north-west of the building*
